## PROPERTY CONDITION REPORT

City Center Marketplace  
15300 East Alameda Parkway & 402 South Chambers Road  
Aurora, Colorado 80017

June 12, 2015  
Partner Project Number: 15-140642.1

Prepared for:  
**A10 Capital**  
Boise, Idaho 83702

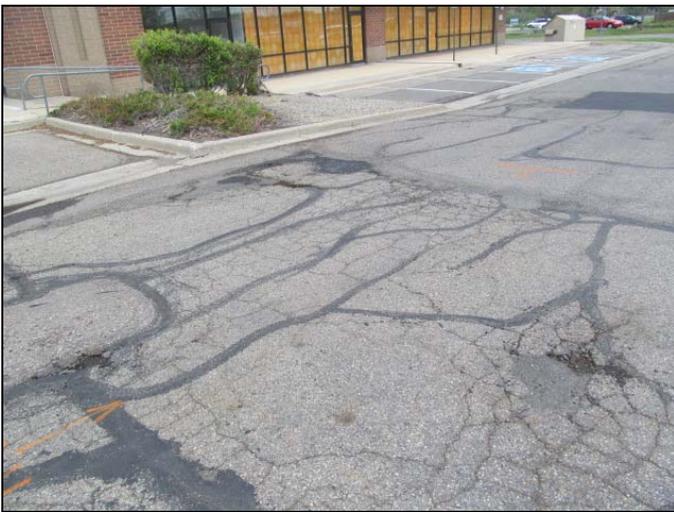
Pavement appears to be in fair structural condition. Linear cracking, "map" or "alligator" cracking, and pothole formation were noted at select site locations. Specific areas of asphalt damage were observed at, but not limited to, the following locations: south of the 420 South Chambers Road. According to property management, a proposal / contract for asphalt repairs was signed on May 4, 2015. The asphalt repair activities will consist of full depth asphalt patching and patching. The total costs for asphalt repairs at the Subject Property is \$34,830. This cost is included in Table 1.

7. View of typical damage observed at the asphalt pavement.

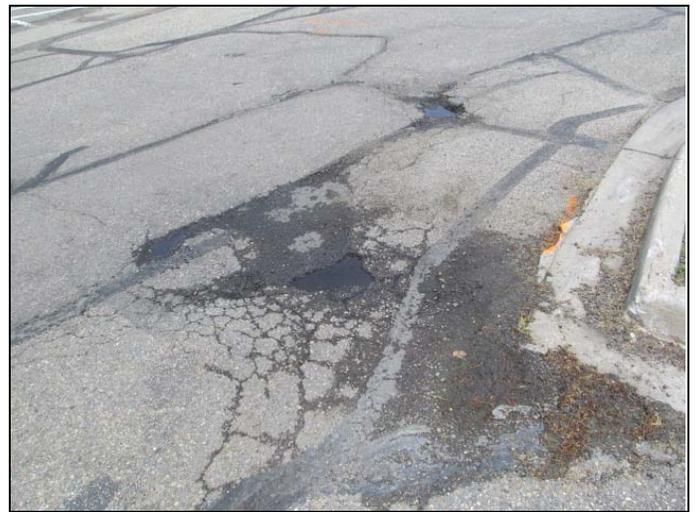
8. View of typical damage observed at the asphalt pavement.

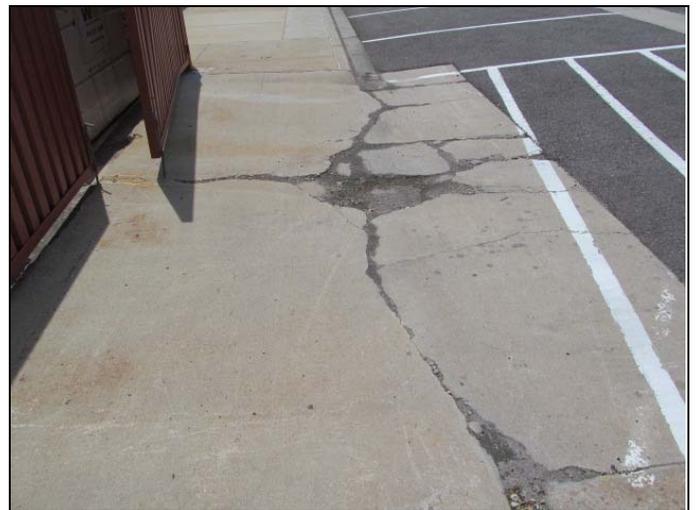
The pedestrian concrete walkways appear to be in fair to good overall condition. Areas of concrete damage, cracking, trip hazards and deterioration was observed throughout the Subject Property. According to property management, a proposal / contract for concrete repairs and replacements was signed on April 15, 2015. The concrete repairs / replacement activities will consist of the removal and replacement of deteriorated / cracked concrete pavement, grinding down of trip hazards and concrete patches. The total costs for concrete repairs / replacement at the Subject Property is \$10,380. This appears sufficient, the cost is included in Table 1.

10. View of typical concrete damage observed at the Subject Property

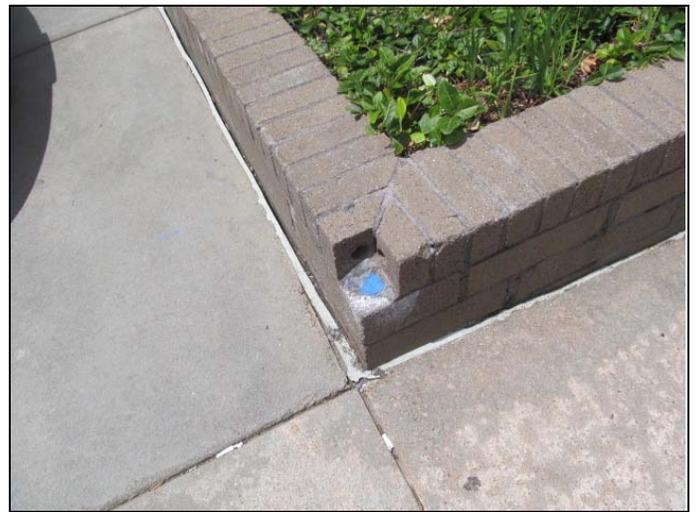
The brick masonry planter beds throughout the Subject Property were observed to be in good overall condition. However, select planter beds were observed to contain damage in the form of cracked or missing brick masonry. Specific areas of damage were observed at, but not limited to, the following locations: adjacent to the Coin Laundry tenant space, adjacent to the vacant tenant space near the former Office Depot tenant space, adjacent to the Sherwin Williams tenant space and adjacent to the Arapahoe County Department of Motor Vehicles tenant space. Partner recommends a complete survey of the masonry

14. View of typical masonry damage at landscaping planter bed.

planter beds at the Subject Property and conducting repairs / replacements as needed. Costs are included in Table 1.

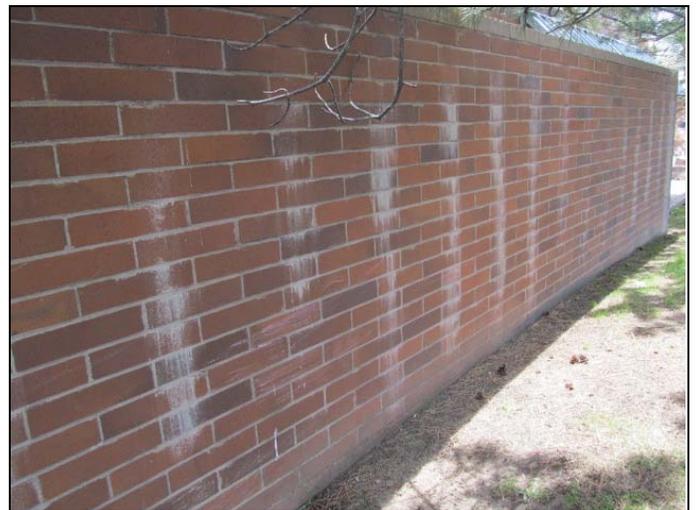
16. View of minor efflorescence observed at the brick masonry wall located to the west of the 420 South Chambers Road building.

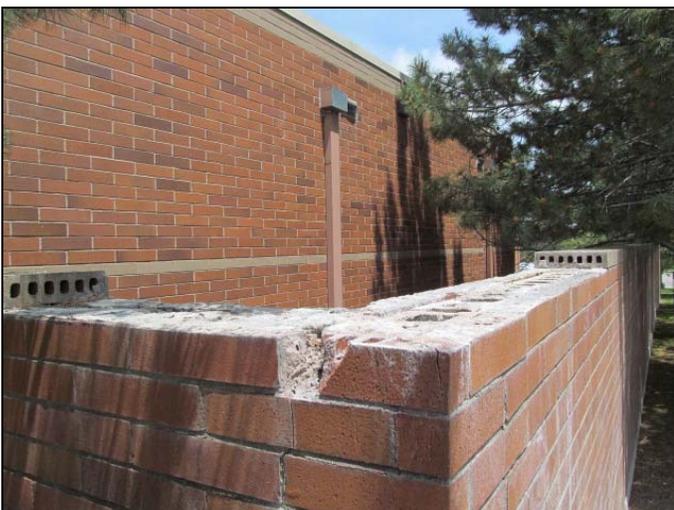
The brick masonry walls were observed to be in good overall condition. However, missing / damaged brick masonry and extensive efflorescence / staining was observed at the wall to the south of the vacant tenant space adjacent to the 24 Hour Fitness. In addition, minor cracking and efflorescence was observed at the wall to the west of the 420 South Chambers Road building. Partner recommends conducting repairs / replacements to the damaged / missing brick masonry and cleaning the staining and efflorescence at the walls. An opinion of costs for this work is included in Table 1.

17. View of damaged brick masonry at the wall located at the rear of the 24 Hour Fitness tenant space.

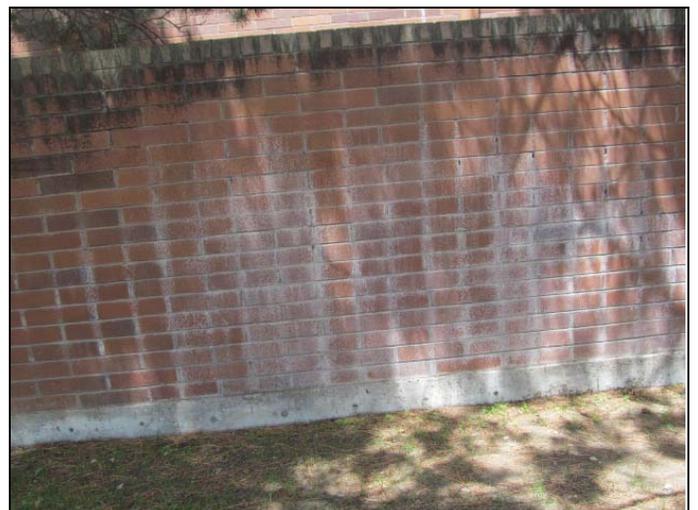
18. View of efflorescence observed at the wall located at the rear of the 24 Hour Fitness tenant space.

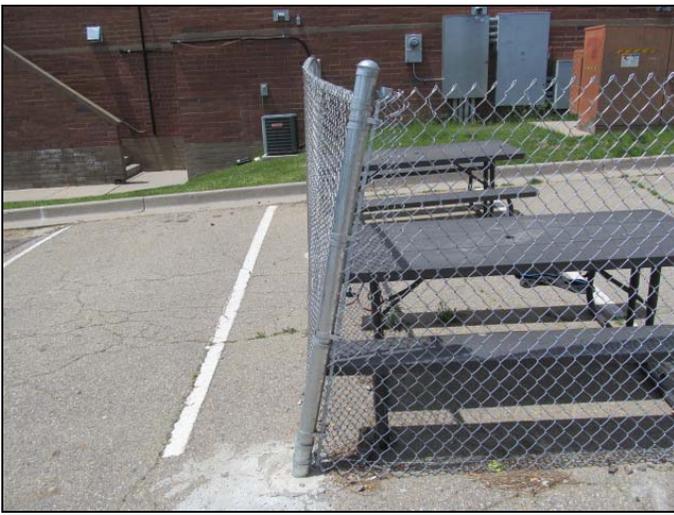
The wood and chain link fencing were observed to be in good overall condition. A minor area of leaning chain link fencing was observed. Routine maintenance is anticipated during the evaluation period.

19. View of the chain link fencing (note leaning section).

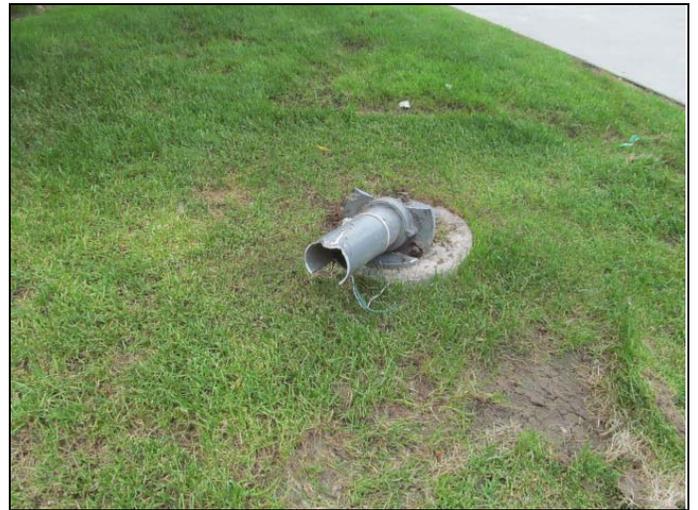
The light fixtures were observed and reported to be in good overall condition. One damaged pole-mounted site light fixture was observed in front of the vacant tenant space adjacent to the 24 Hour Fitness tenant space. Partner recommends replacing the pole-mounted lighting fixture. An opinion of costs are included in Table 1. The light fixtures are anticipated to require minimal repairs and replacements that can be addressed as part of routine maintenance during the evaluation period.

22. View of damaged light pole.

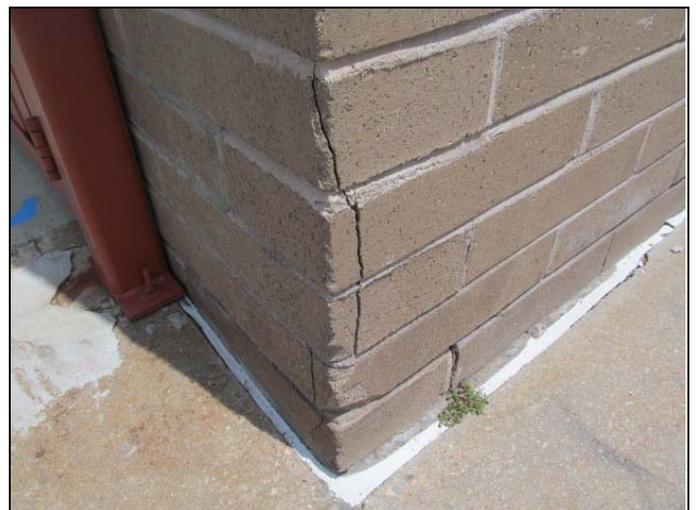
The brick masonry and CMU trash enclosures were observed to be in good overall condition. However, minor cracking and minor concrete deterioration was observed at the trash enclosure to the west and east of the 15300 East Alameda Parkway building and to the east of the 406 South Chambers Road building. Minor rusting was observed at the trash enclosure doors adjacent to the Family Dollar tenant space. An opinion of costs are included in Table 1. Painting of the CMU trash enclosure can be conducted in conjunction with the exterior painting of the buildings.

24. View of typical cracking observed at typical trash enclosures.

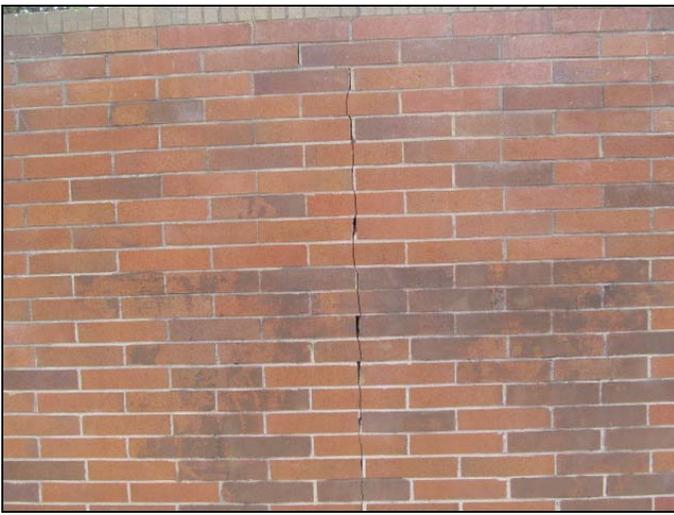
25. View of typical cracking observed at typical trash enclosures.

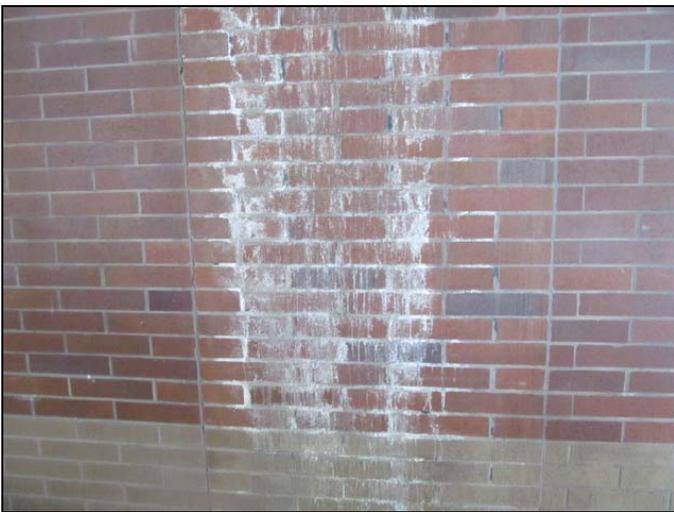
4.3	Minor efflorescence was observed on the inside of the exterior brick masonry walls at the vacant tenant spaces of the 420 South Chambers Road building. The efflorescence was observed to be in minor in nature. Partner recommends cleaning the areas of efflorescence and continued monitoring of the interior portions of the brick masonry walls during the evaluation period.	1	LS	\$750	\$750		\$750

27. View of efflorescence observed at the interior of the exterior brick masonry walls.

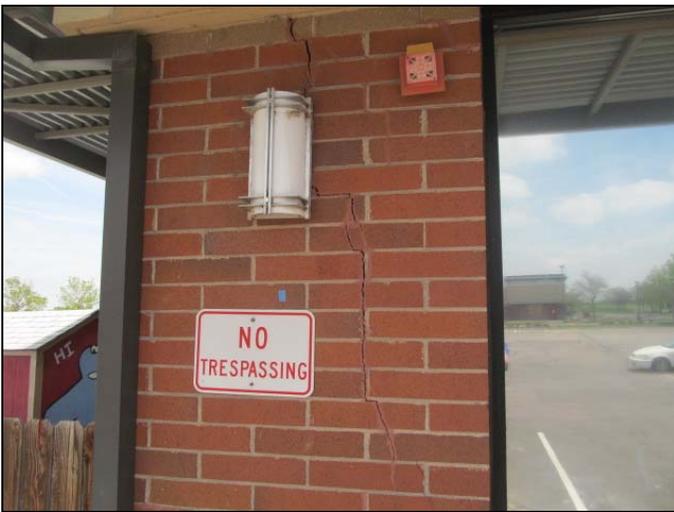
31. View of minor cracking observed at the brick masonry near the entrance to the First Step Infant Daycare tenant space.

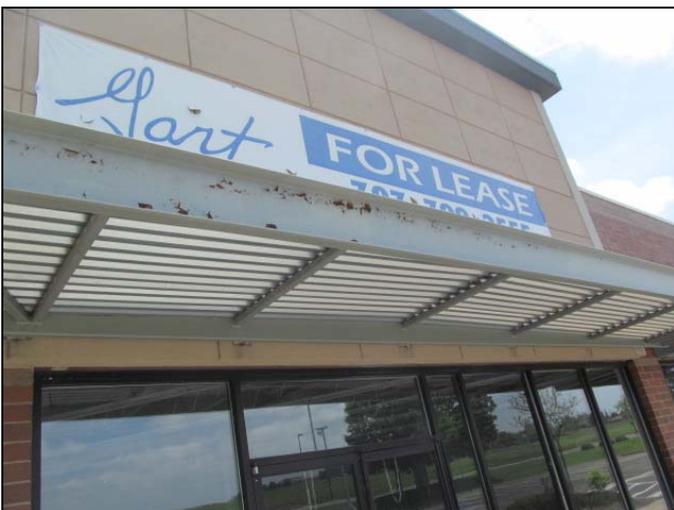
35. View of minor rusting observed at select steel and corrugated metal awning structures.

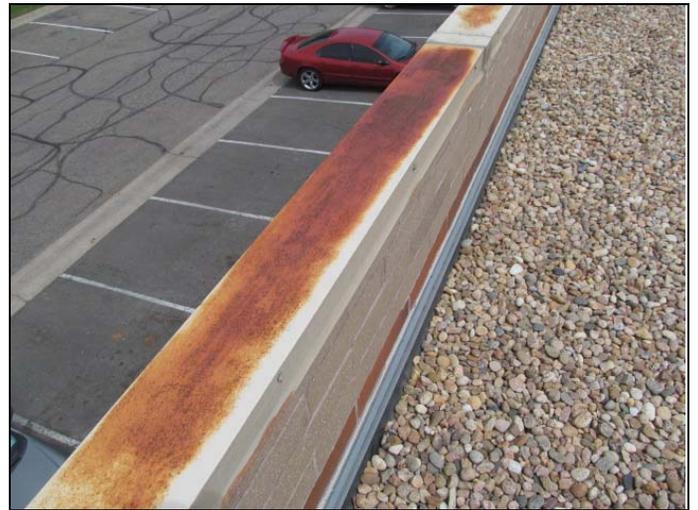
4.4.4	Several areas of rusted sheet steel copings were observed at the parapet walls. Partner recommends a complete survey of the sheet steel copings and conducting replacements and sealing as need. A cost allowance for this work is included.	4,000	LF	\$3.00		\$12,000	\$12,000

40. View of typical rusting observed at parapet coping.

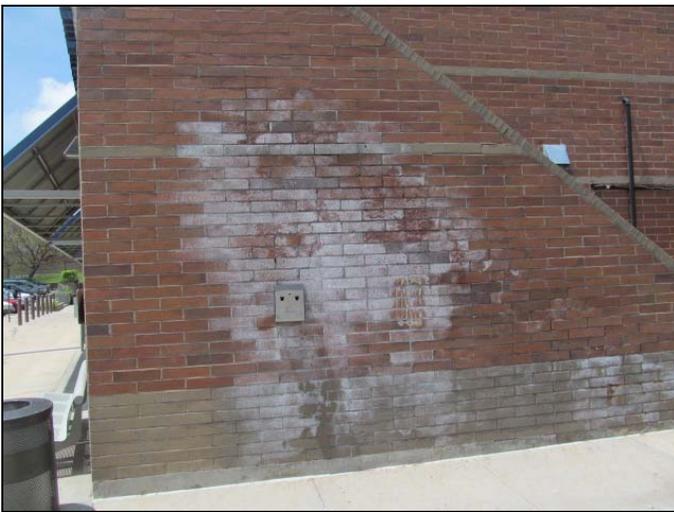
4.6	The exterior stairs at the rear of the 406 South Chambers Road building were observed to contain efflorescence and cracking at the brick masonry enclosure walls and cracked / deteriorated concrete steps. Partner recommends conducting repairs / replacements at the damaged exterior stairs at the 406 South Chambers Road building. An opinion of costs associated with repairs / replacements is included.	1	LS	\$2,500	\$2,500		\$2,500
<b>5.0 Mechanical and Electrical Systems</b>							
<b>6.0 Interior Elements</b>							
<b>7.0 Accessibility</b>

43. View of efflorescence at the exterior stair structure observed at the rear of the 406 South Chambers Road building.

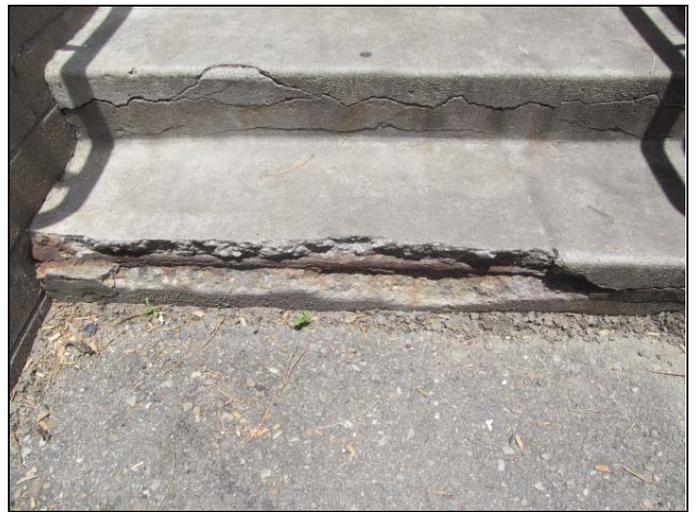
44. View of typical damaged concrete steps.

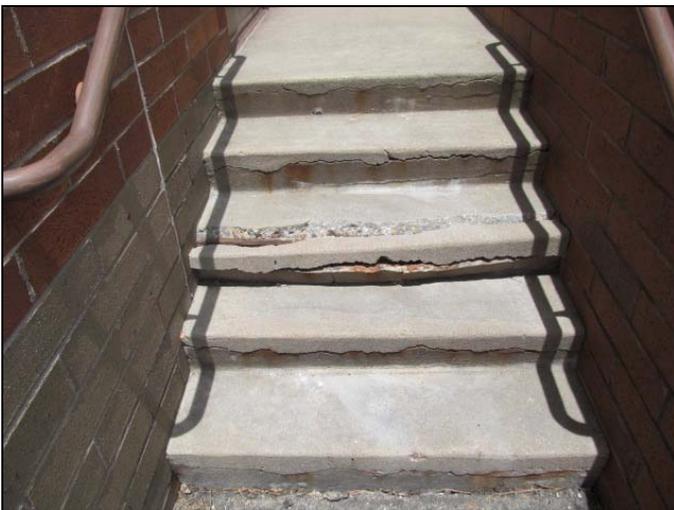
45. View of typical damaged concrete steps.

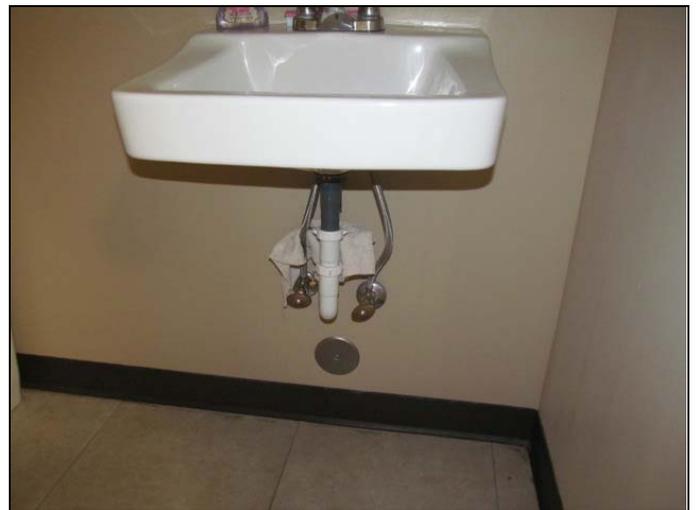
58. Select tenant spaces lacked appropriate scald protection per ADAAG.

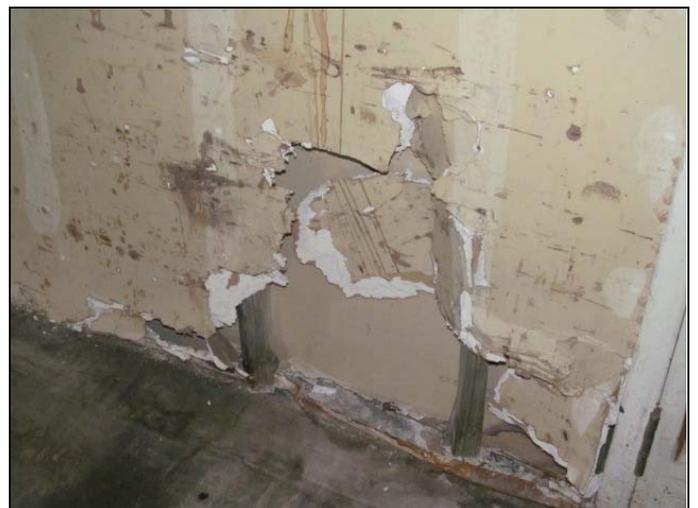
60. View of typical drywall damage observed at vacant tenant spaces.
