## **PHASE II - METHANE GAS TEST**

**EDGE POINT III  
EAST SIDE of PEORIA STREET BETWEEN 11<sup>th</sup> & 13<sup>th</sup> AVENUE  
AURORA, COLORADO**

November 18, 2019

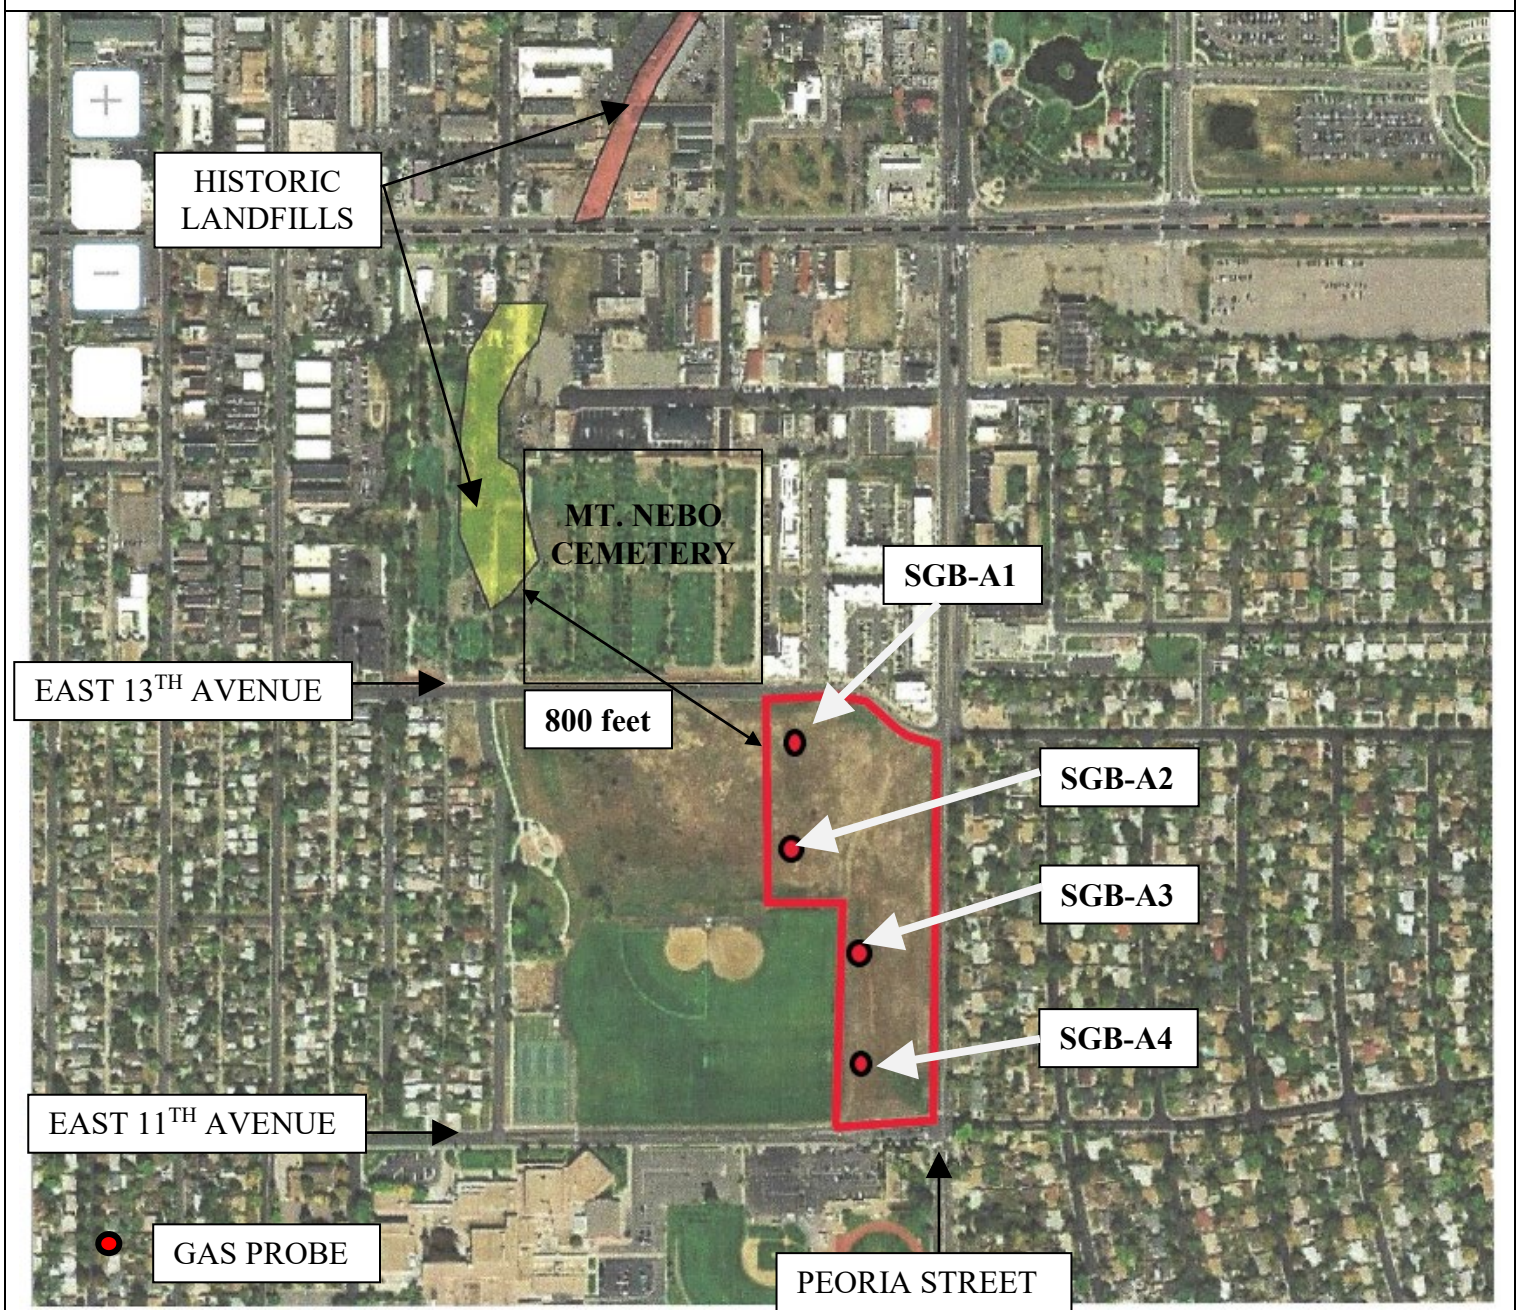
<div>GAS PROBE LOCATION</div>	<div>Scale:</div>	<div>1 " = 400 FEET</div>
<div>AURORA, COLORADO</div>	<div>FIGURE 1</div>	<div>

The subsurface investigation was conducted on November 6, 2019 by advancing shallow borings on the western edge of the Property using a stainless steel hand auger. The location of these boreholes is shown on Figure 1. During the advancement of the boreholes, the general soil lithology encountered in all four boreholes was as follows:

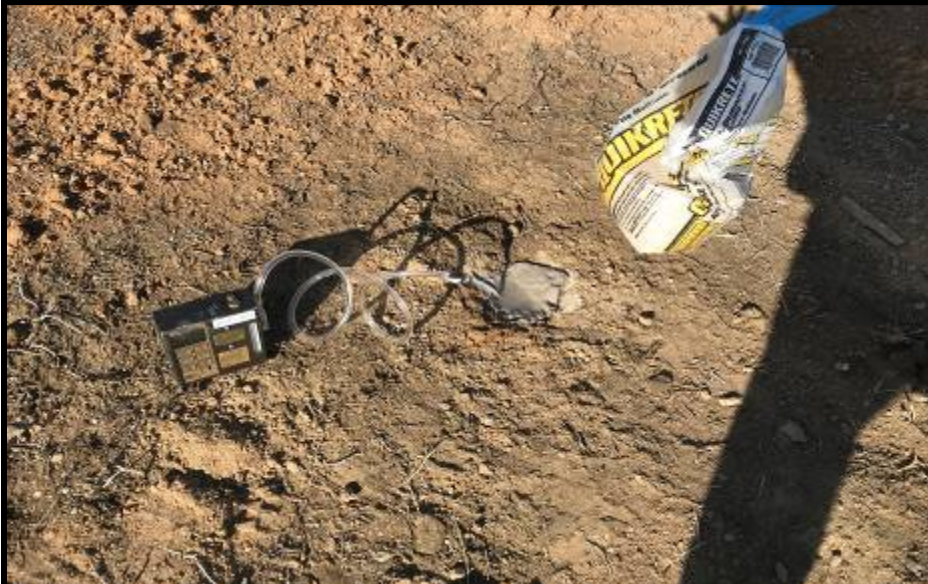
Photo 3:  
Air Vacuum Pump Removing air in  
lines

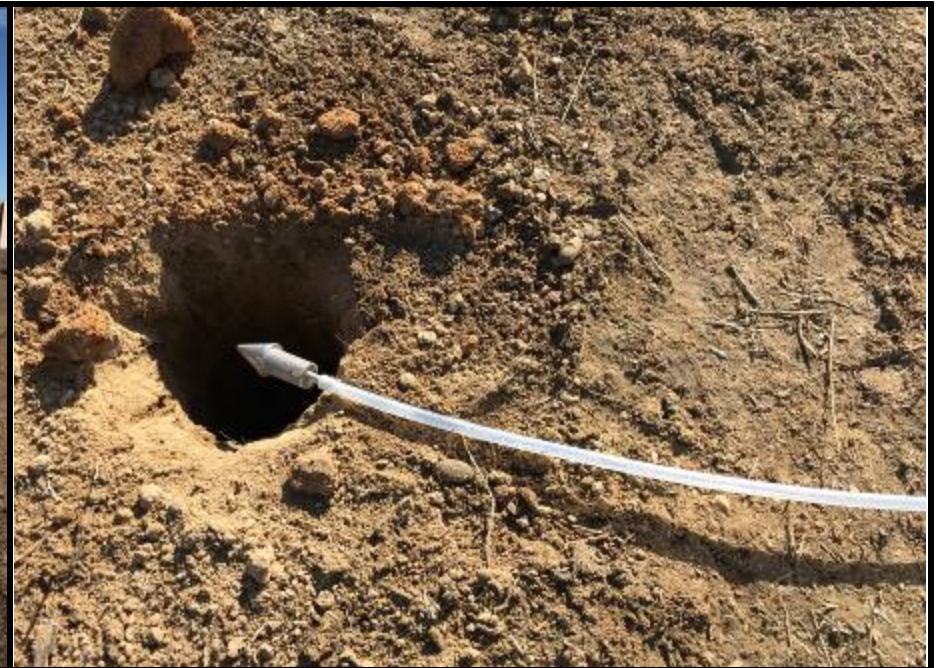
Photo 5:  
Screened Vapor Point

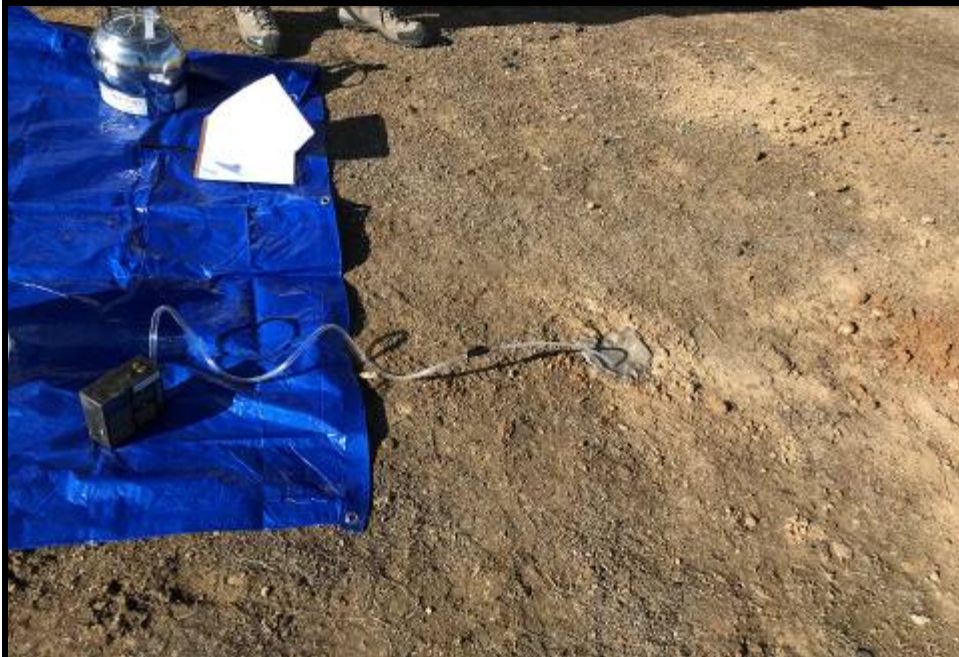
Photo 6:  
Sealed Vapor Point

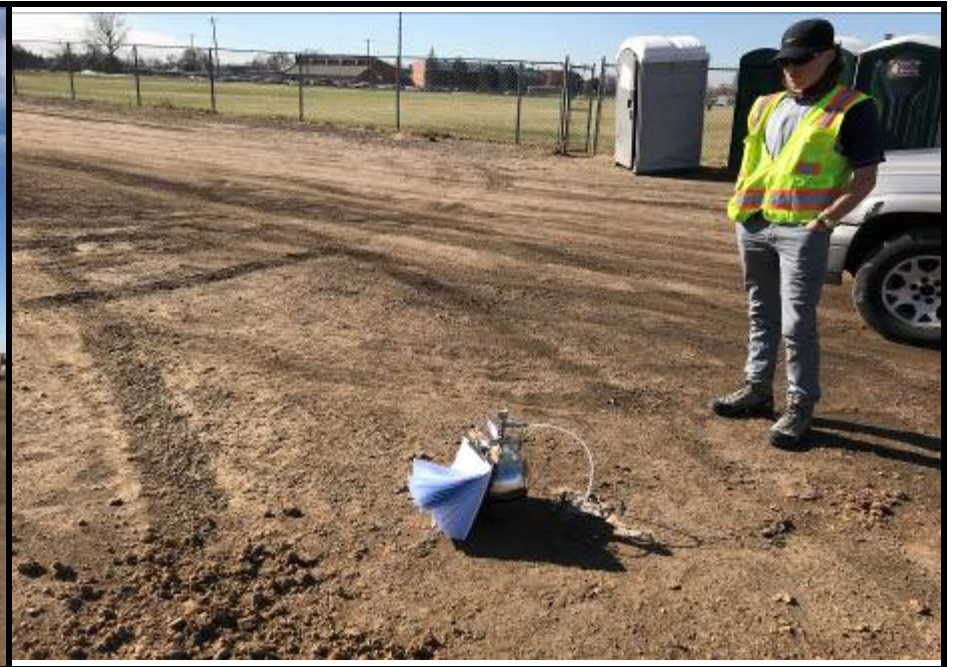
Photo 8:  
Completing Vapor Test at the South  
End SBG-A4
