**Aurora Mental Health Center**

**1290 South Potomac Street**

**Tree Survey and Assessment**

## **RE: Tree Survey and Assessment: 1290 S. Potomac Street**

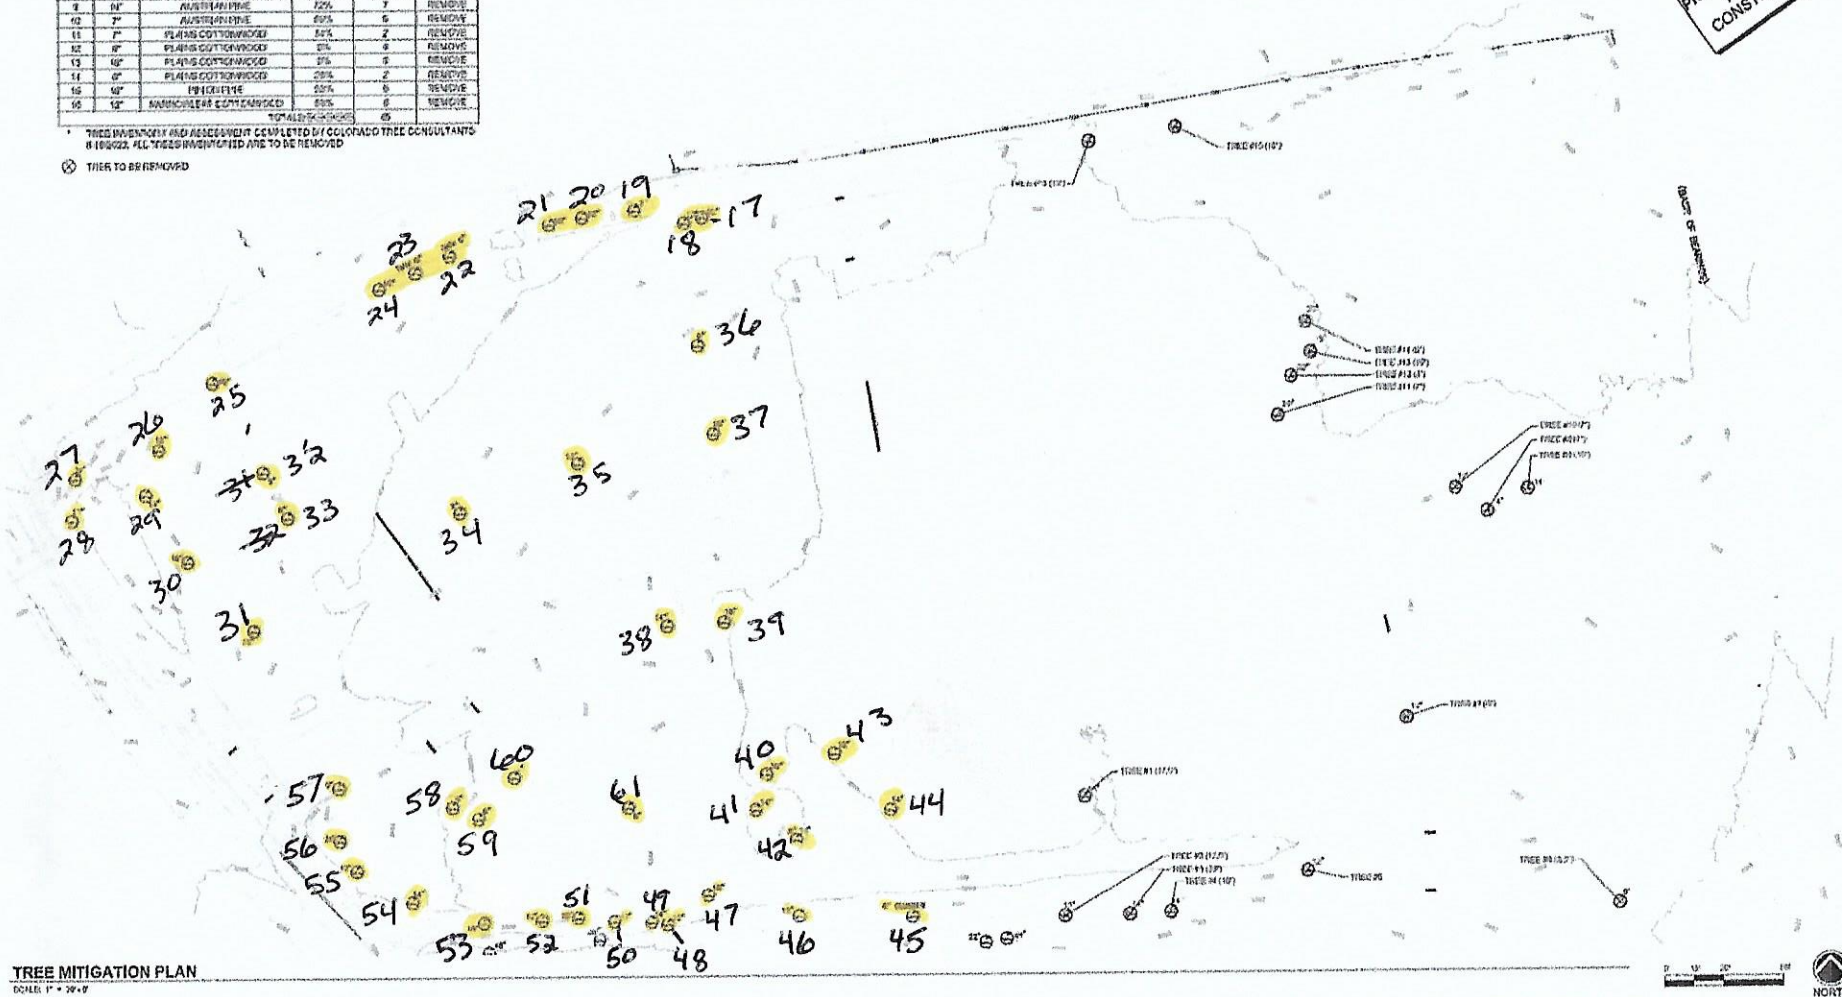
**TREE MITIGATION PLAN**  
SCALE: 1" = 20'-0"

**TREE INVENTORY AND ASSESSMENT\***

TREE #	DBH (INCH)	SPECIES	CONDITION	MITIGATION INCHES	REMOVAL OR RETAIN
1	12"	LANCELEAF FLEET MAPLE	70%	13	REMOVE
2	12"	AUSTRIAN PINE	0%	0	REMOVE
3	12"	AUSTRIAN PINE	72%	17	REMOVE
4	10"	AUSTRIAN PINE	70%	12	REMOVE
5	8"	PLAINS COTTONWOOD	0%	0	REMOVE
6	8"	PEACH PINE	0%	0	REMOVE
7	8"	AUSTRIAN PINE	70%	0	REMOVE
8	7"	AUSTRIAN PINE	72%	0	REMOVE
9	6"	AUSTRIAN PINE	72%	7	REMOVE
10	2"	AUSTRIAN PINE	0%	0	REMOVE
11	1"	PLAINS COTTONWOOD	0%	2	REMOVE
12	6"	PLAINS COTTONWOOD	0%	0	REMOVE
13	6"	PLAINS COTTONWOOD	0%	0	REMOVE
14	6"	PLAINS COTTONWOOD	0%	2	REMOVE
15	6"	PEACH PINE	0%	0	REMOVE
16	12"	SAVING LEAF COTTONWOOD	0%	0	REMOVE
TOTALS			0%	0

⊗ TREE TO BE REMOVED
