Stafford Logistics Center
Existing Conditions Map
Tab #4
Natural Features Map

Stafford Logistics Center Existing Conditions Map Tab #4 Forestry - Tree Survey

Stafford Logistics Center
Existing Conditions Map
Tab #4
Slope Analysis

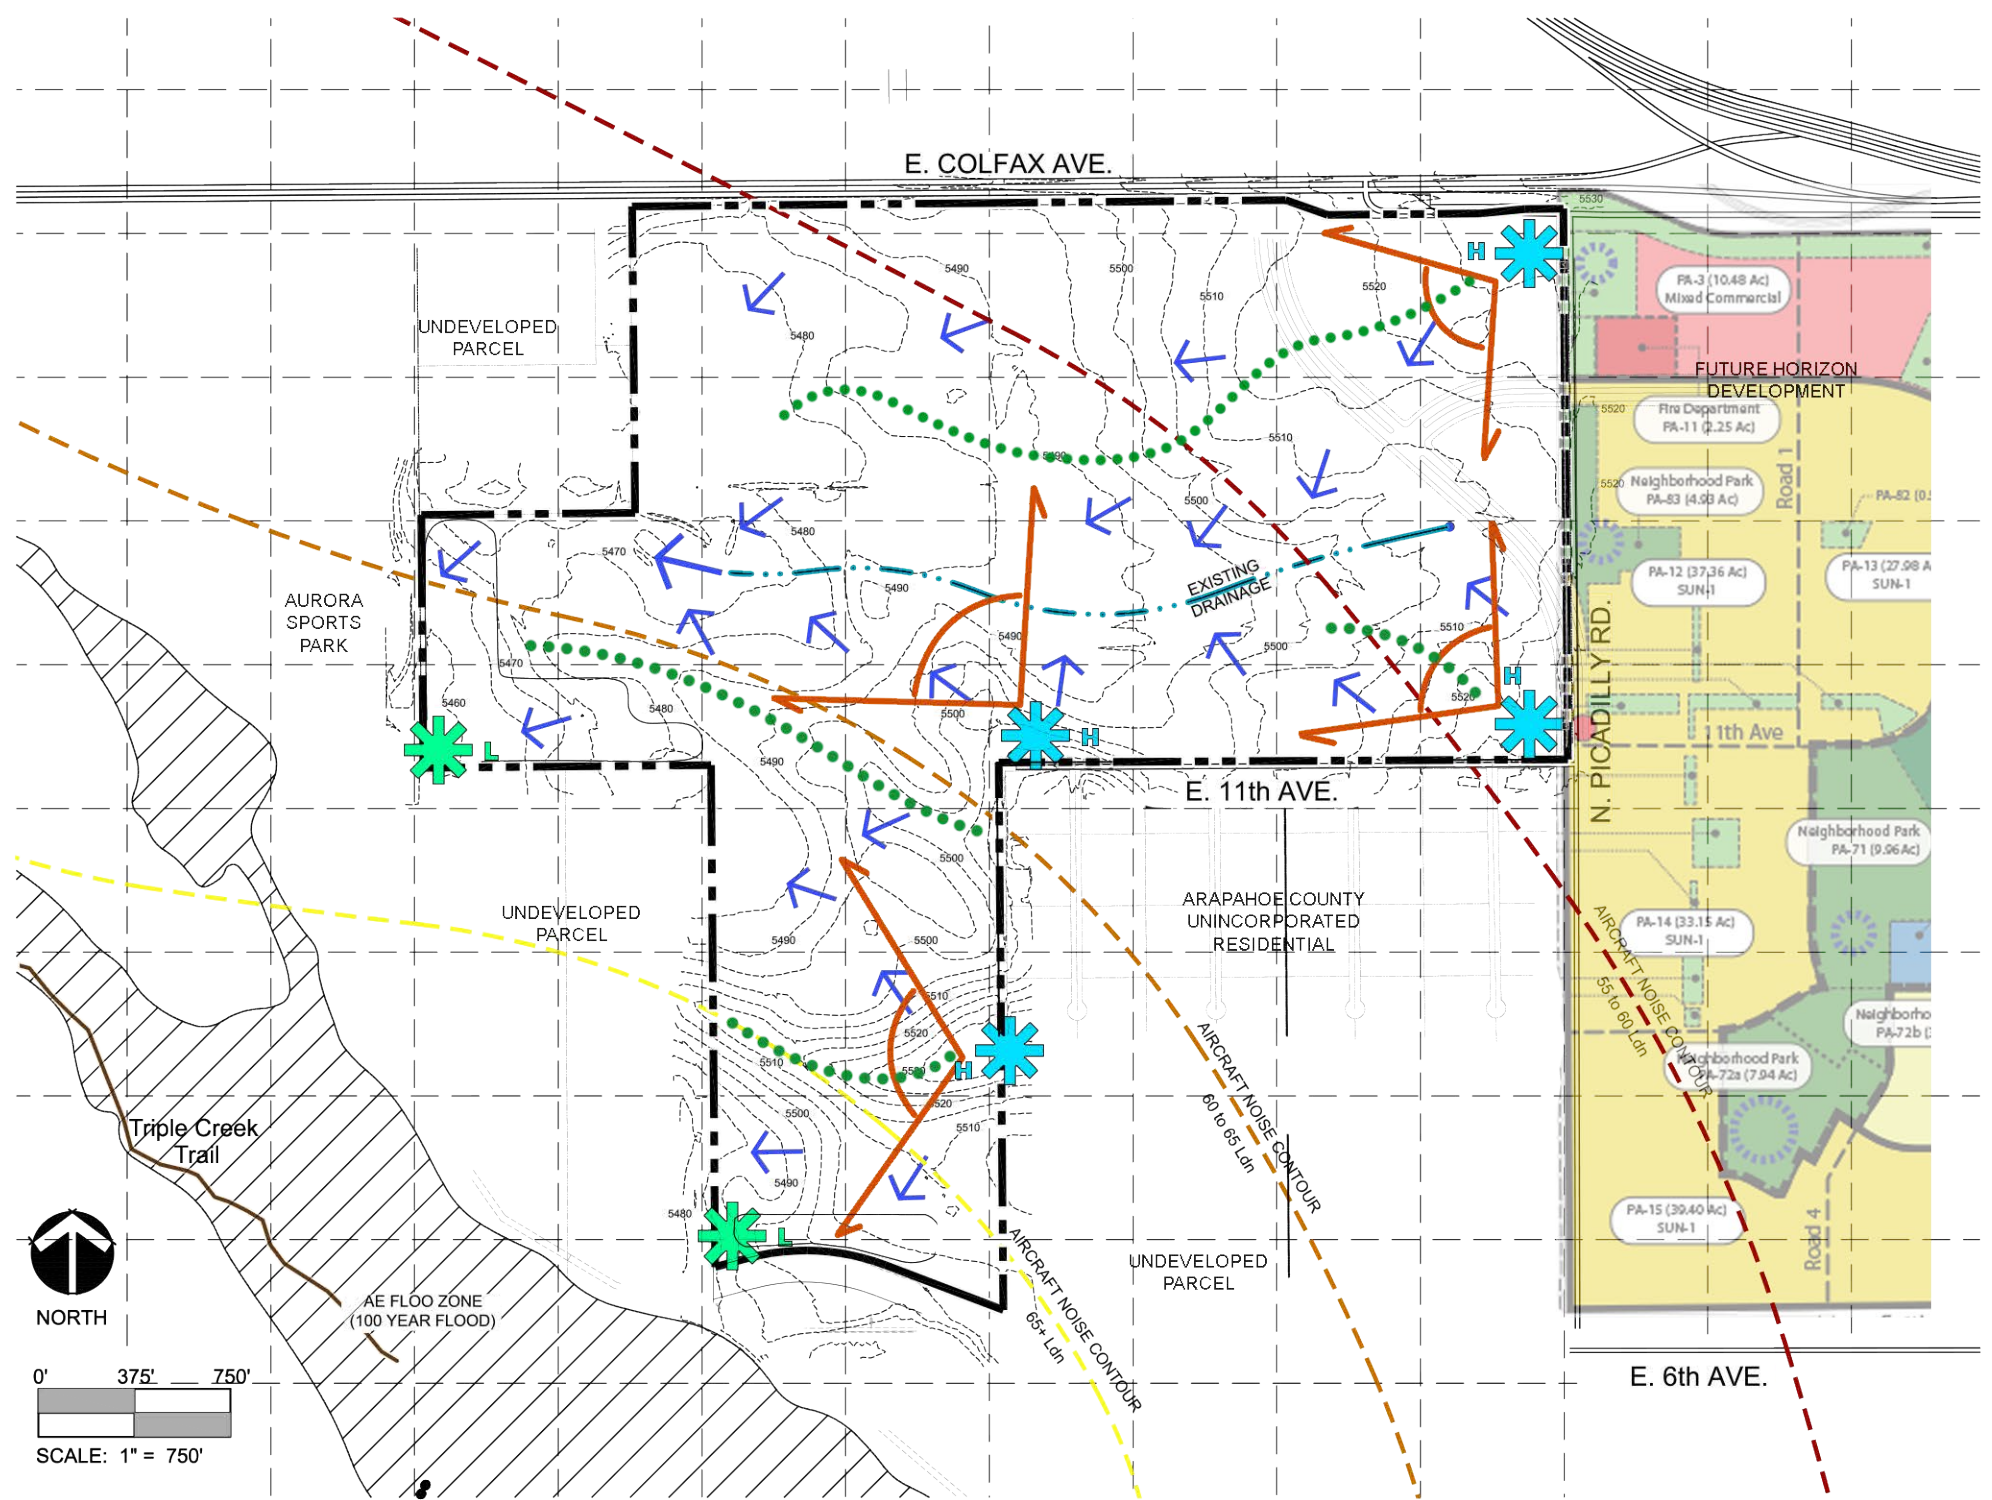
- PROPERTY BOUNDARY
- 10 ACRE REFERENCE GRID
- AIRCRAFT NOISE EXPOSURE BUCKLEY AIRFORCE BASE
- EXISTING GRADING HIGH POINT
- EXISTING GRADING LOW POINT
- VIEW CORRIDOR
- RIDGE
- EXISTING GRADING SURFACE FLOW (ARROWS POINT DOWN HILL)
- EXISTING GRADING DRAINAGE PATH
- 100 YEAR FLOOD LIMIT (FEMA AE FLOOD ZONE)

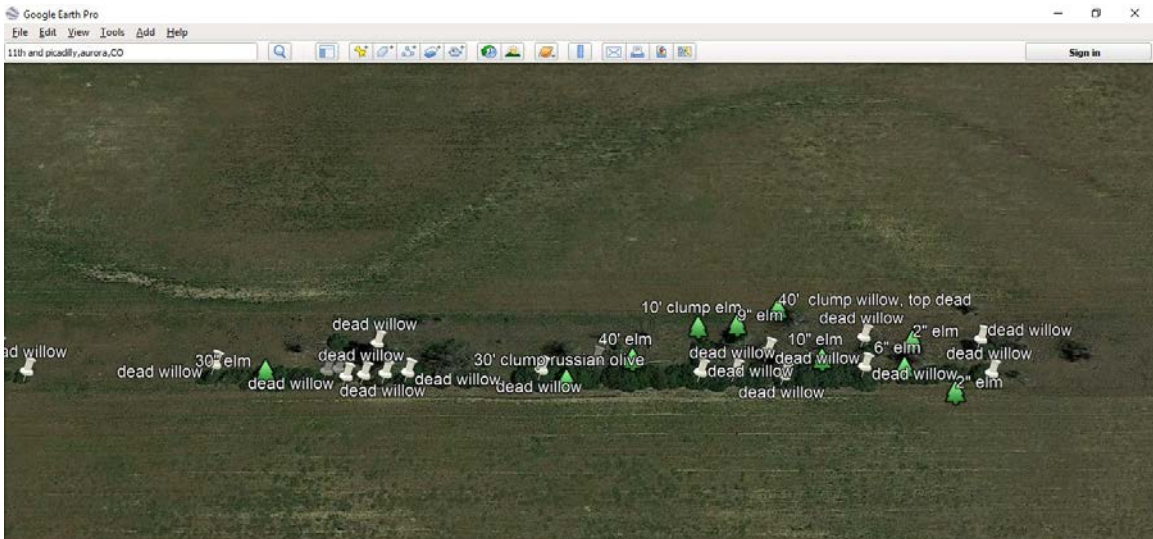
Center treed section

White pins are dead trees, Green trees are live trees

Multistem clumped trees are measured .in height in feet

Singlestem trees are in diameter inches

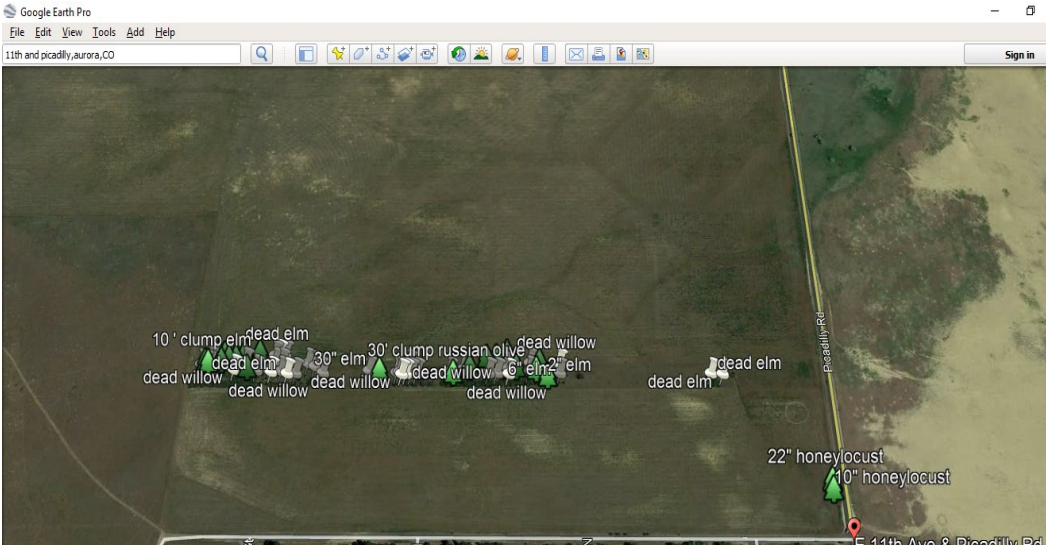
Treed Section

White pins are dead trees, Green trees are live trees

Multistem clumped trees are measured .in height in feet

Singlestem trees are in diameter inches

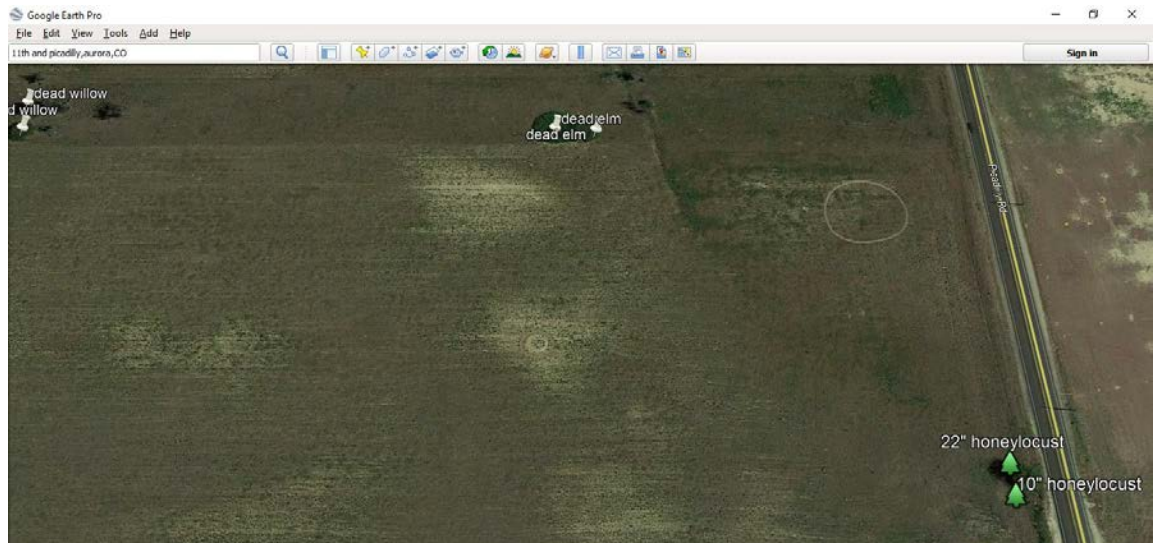
Eastmostmost treed section

White pins are dead trees, Green trees are live trees

Multistem clumped trees are measured .in height in feet

Singlestem trees are in diameter inches

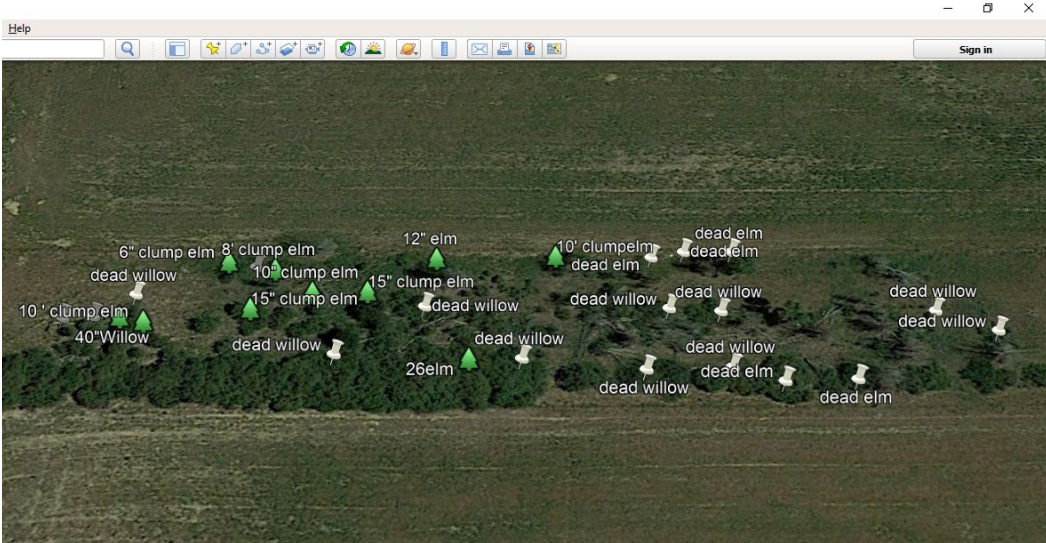
Westmost treed section

White pins are dead trees, Green trees are live trees

Multistem clumped trees are measured .in height in feet

Singlestem trees are in diameter inches

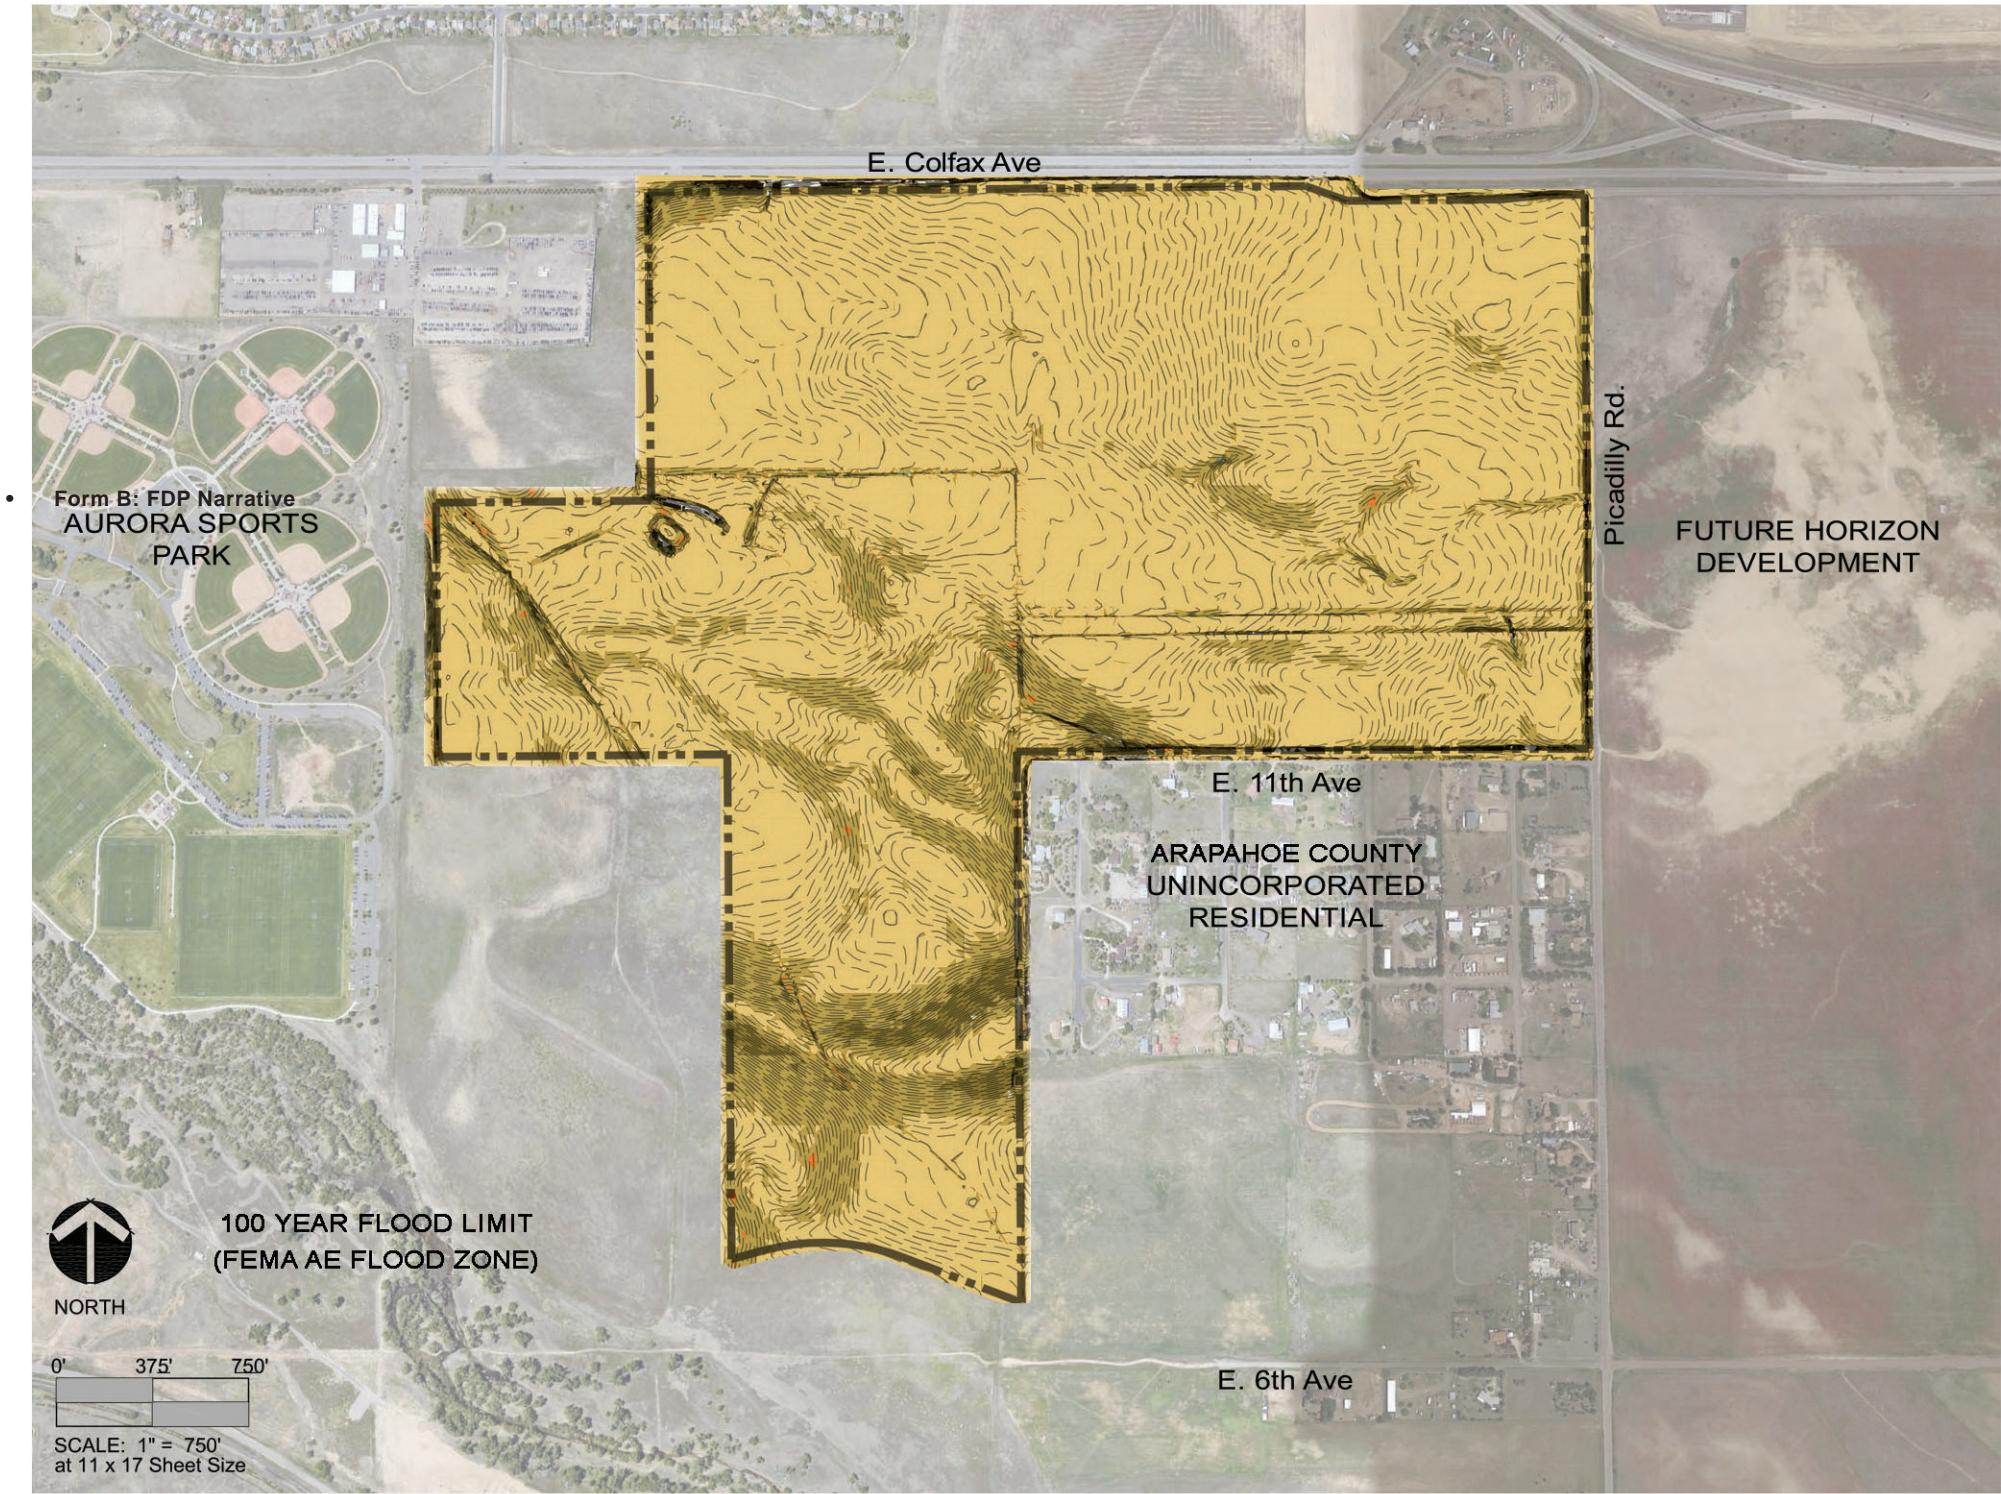
Slopes Table				
Number	Minimum Slope	Maximum Slope	Area	Color
1	0.00%	5.00%	14522672.6 S.F.	
2	5.00%	10.00%	3034765.0 S.F.	
3	10.00%	15.00%	663858.5 S.F.	
4	15.00%	20.00%	236809.5 S.F.	
5	20.00%	25.00%	128707.8 S.F.
