**RE: Spine G Pipeline Environmental Review and Site Inspection, Adams & Arapahoe Counties, CO**

This letter report describes methods, findings, and recommendations regarding the assessment of sensitive plant and wildlife resources and at the Spine G Pipeline project site.

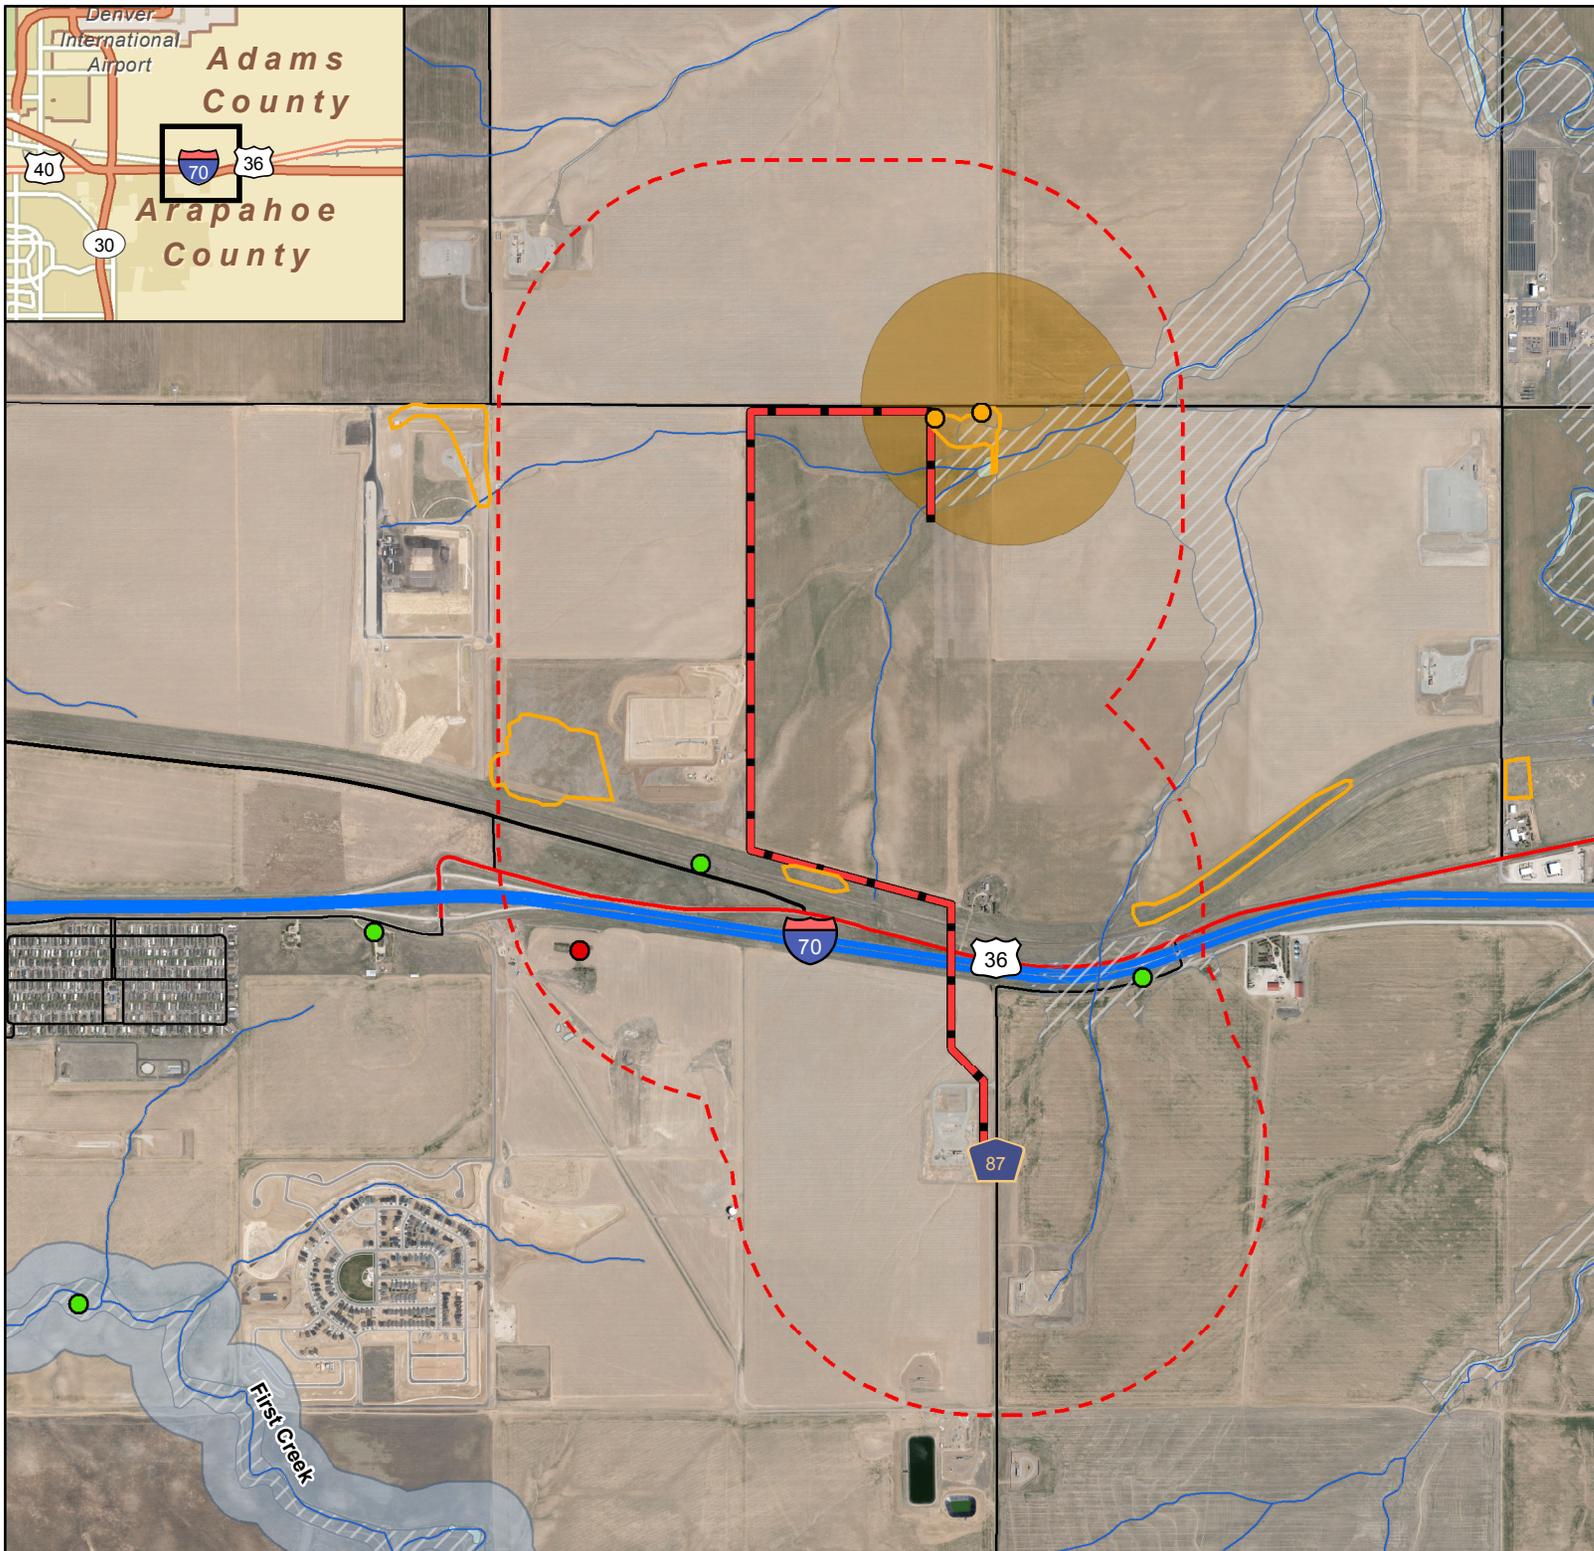
**Figure 1**

**Spine G Pipeline  
Project Overview**

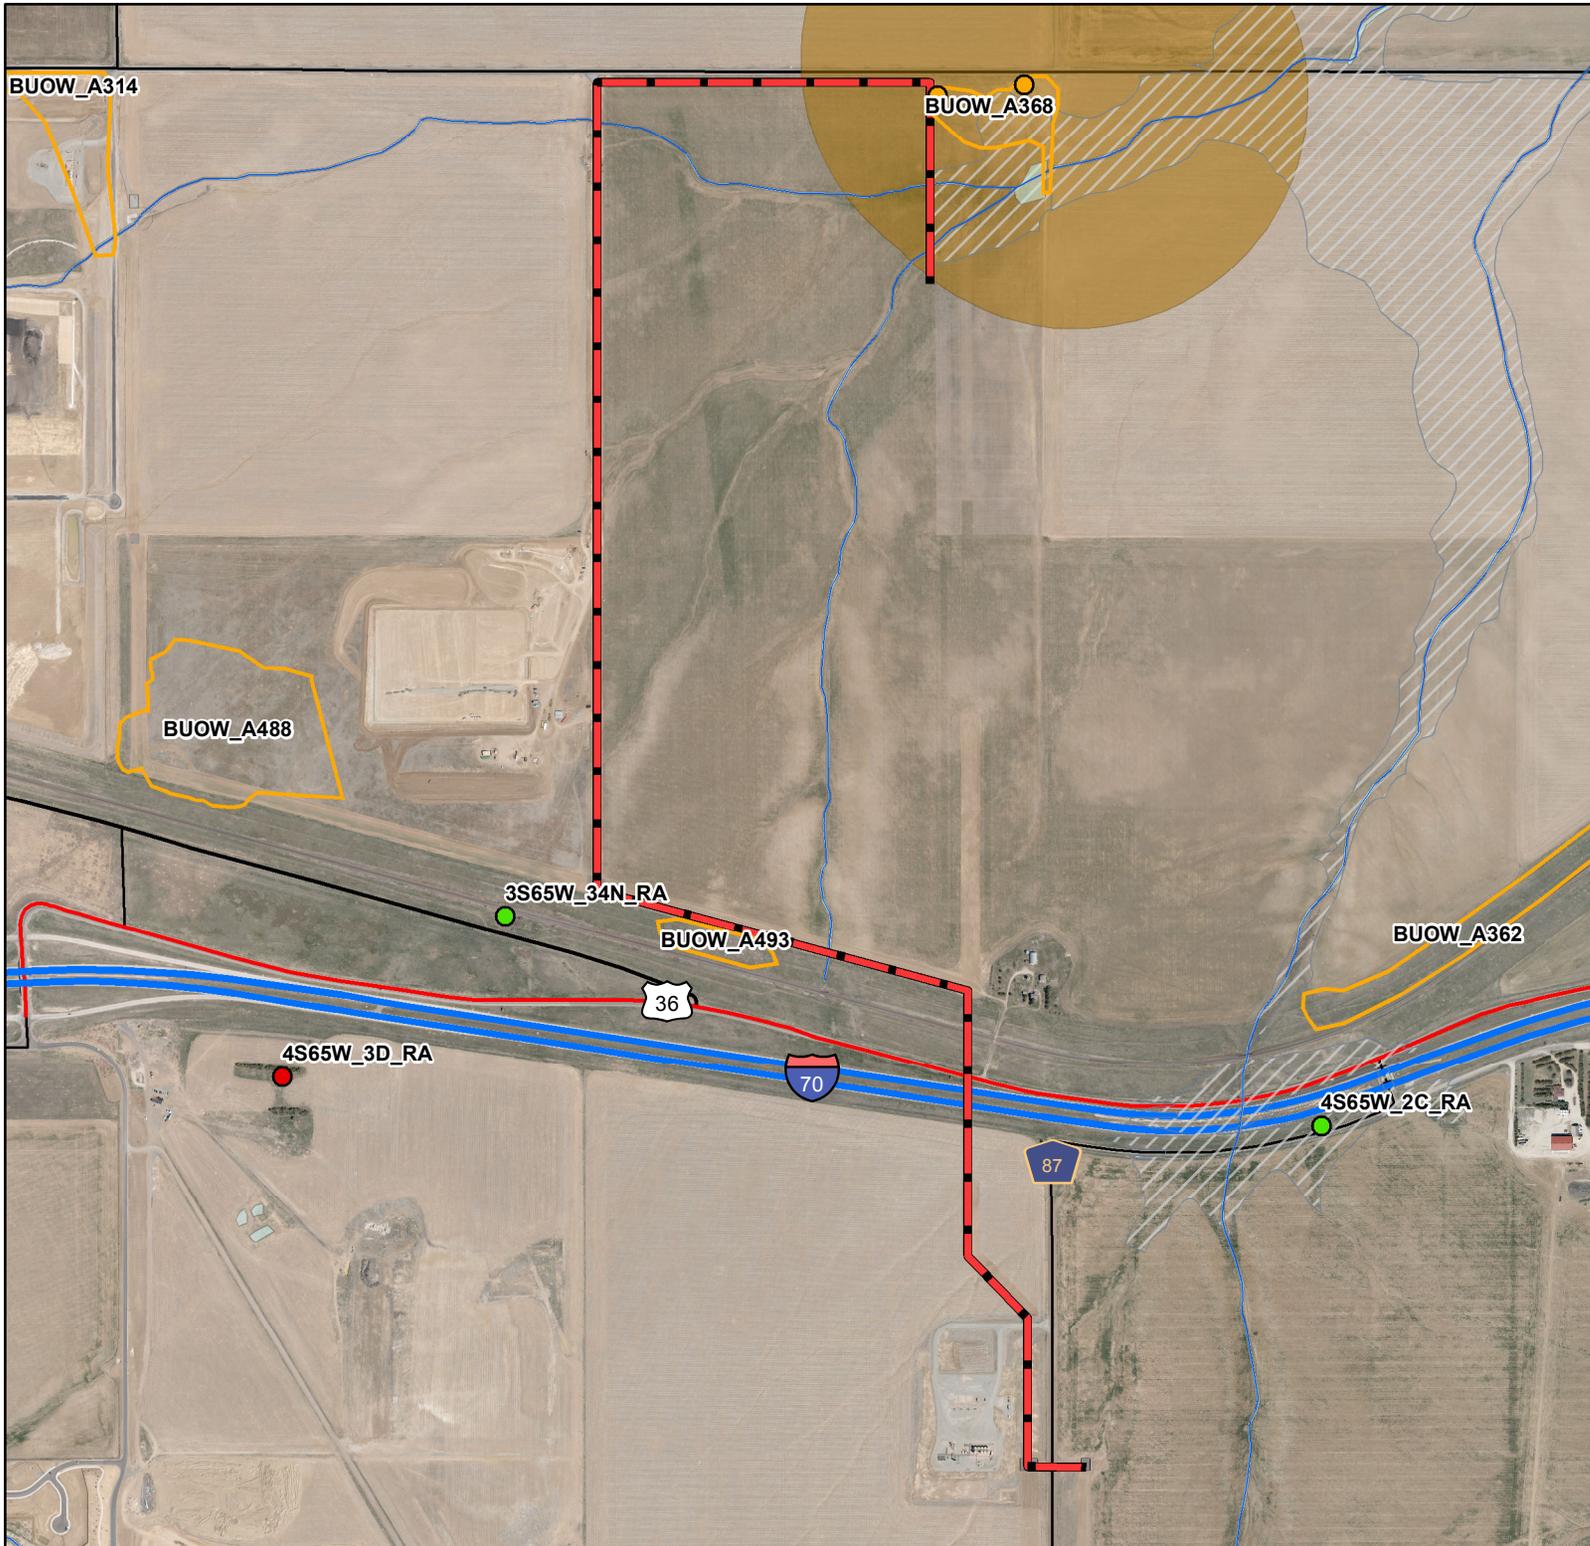
**Figure 2**

The northeastern portion of the pipeline is along the boundary of the Federal Emergency Management Agency (FEMA)-mapped 100-year floodplain for a tributary of Box Elder Creek (Figure 2)

There are three (3) known non-eagle raptor nests within one-half mile of the Project Area, as well as additional trees suitable for nesting raptors. One nest (4S65W\_3D\_RA) was active with at least one great horned owl nestling at the time of the field site survey; this nest is located 0.4 mile southwest of the pipeline, outside the CPW-recommended 0.125-mile buffer for active great horned owl nests. The other two nests (3S65W\_34N\_RA and 4S65W\_2C\_RA), located 0.1 mile southwest and 0.38 mile east of the pipeline, were both inactive at the time of the field site survey (Figure 2).

**Spine G Pipeline  
Natural Resource Features**

**An Adams County Floodplain Use Permit may be required.**

**Apex recommends raptor nesting surveys approximately one week prior to the start of construction if construction begins between February 1 and July 31.**

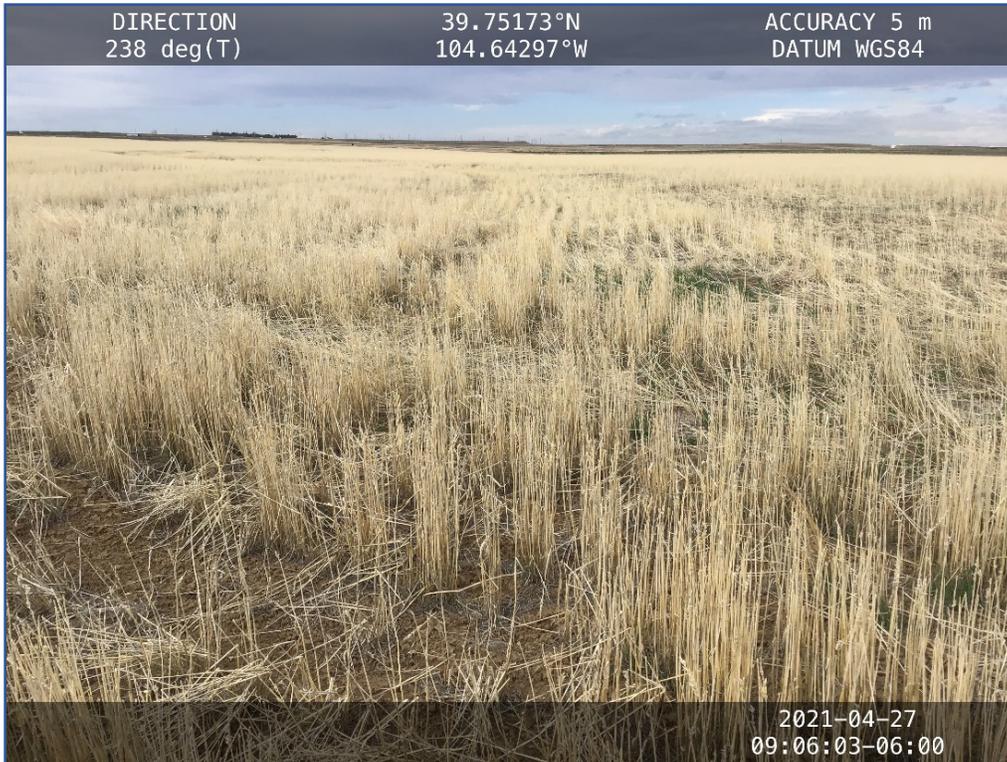
There are no wetlands or other potential waters of the U.S. within the Project Area. The NHD and NWI datasets indicate that tributaries of Box Elder Creek intersect the pipeline in four (4) locations (Attachment A - Figure 2); however, no evidence of hydrophytic vegetation or signs of surface waters was observed at these locations (Attachment B - Photos 3 – 6, 12 – 13, and 15).

**Photo 3.** Looking southwest along mapped intermittent stream intersecting the northeastern section of pipeline.

**No Clean Water Act Section 404 permit will be necessary for pipeline construction. Stormwater control measures within the Project Area may be subject to CDPHE regulations.**

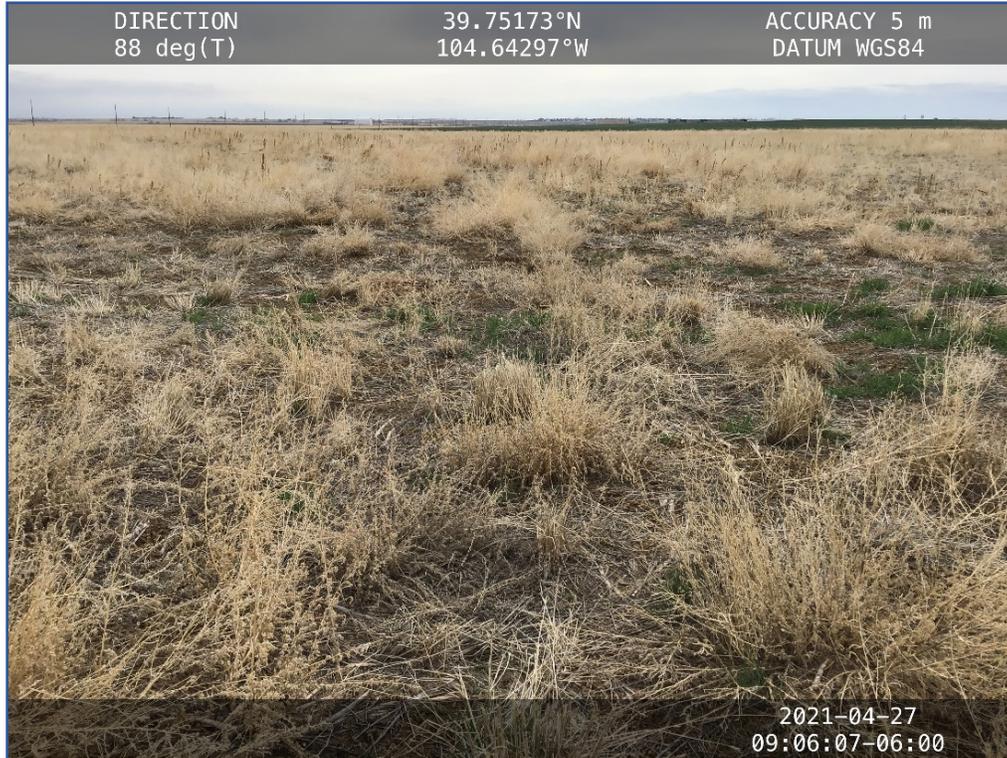
**Photo 4.** Looking northeast along mapped intermittent stream intersecting the northeastern section of pipeline.

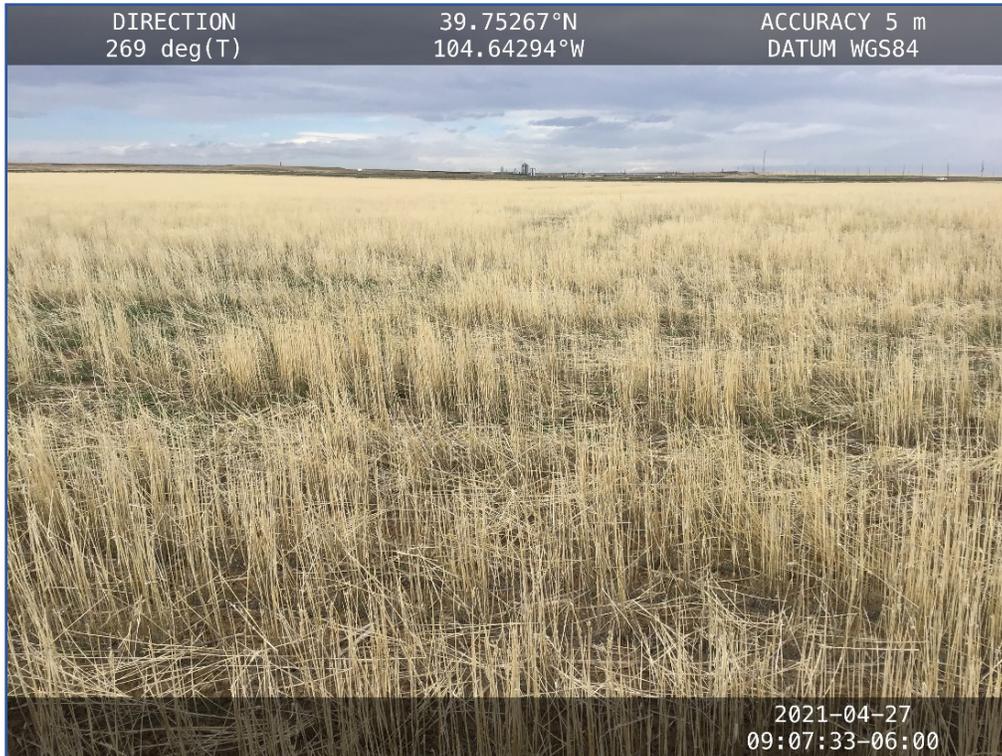
**Photo 5.** Looking west along mapped intermittent stream intersecting the northeastern section of pipeline.

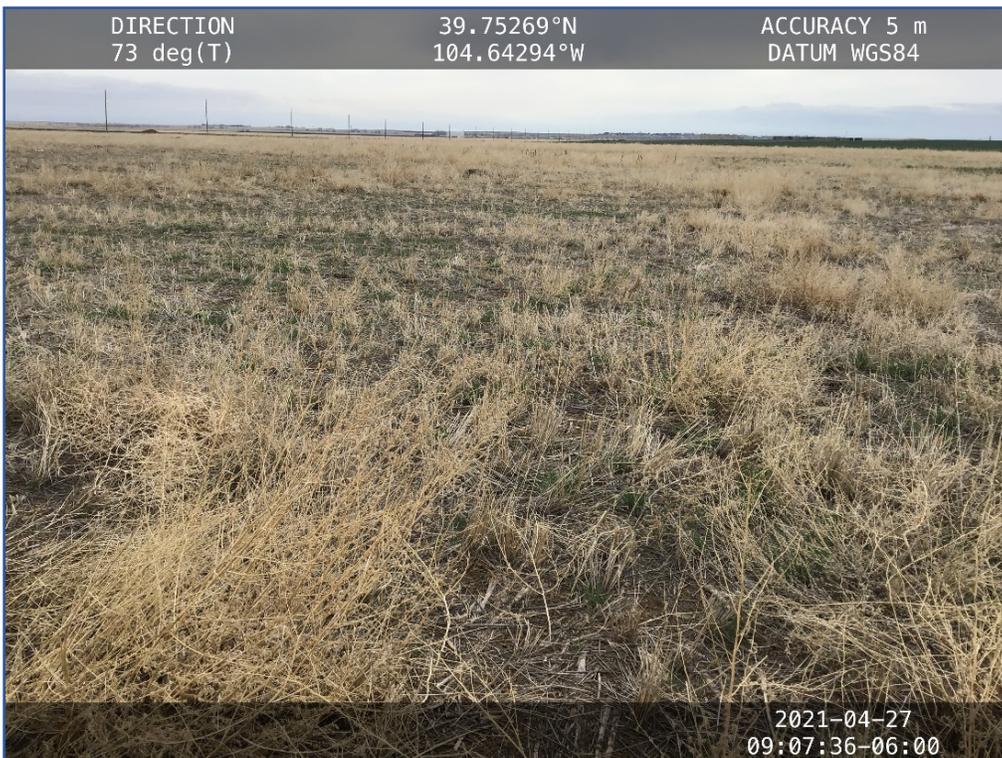
**Photo 6.** Looking east along mapped intermittent stream intersecting the northeastern section of pipeline.

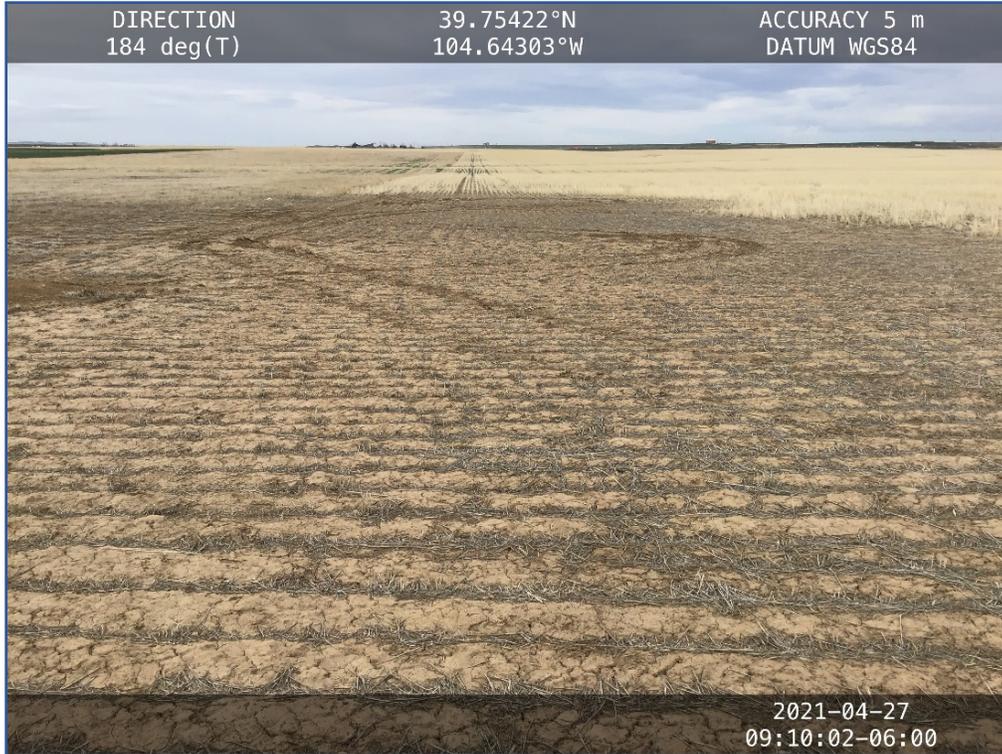
There are two separate areas of suitable burrowing owl habitat within 660 feet of the Project Area: BUOW\_A368 overlaps the northeastern portion of the pipeline, and BUOW\_A493 is approximately 30 feet south of the middle horizontal section of the pipeline. BUOW\_A368 is also mapped by CPW as an active nest location (Figure 2). At least four (4) burrowing owls (two pairs) were observed in BUOW\_A368 during the field site survey, perched within 40 feet of the pipeline, at the closest. No burrowing owls were observed in BUOW\_A493.

**Photo 7.** Looking south towards northeastern terminus of pipeline. Burrow on far left (east) side of photo is one location where pair of burrowing owls was observed.

**Apex recommends additional burrowing owl surveys if construction will begin between March 15 and October 31 to determine if the owls remain present. CPW recommends three consecutive negative burrowing owls, each separated by approximately one week, to conclude that burrowing owls are not present. If burrowing owls are determined to be present and nesting within 660 feet, CPW recommends delaying activities until after October 31 or until it can be confirmed that the owls are no longer present.**

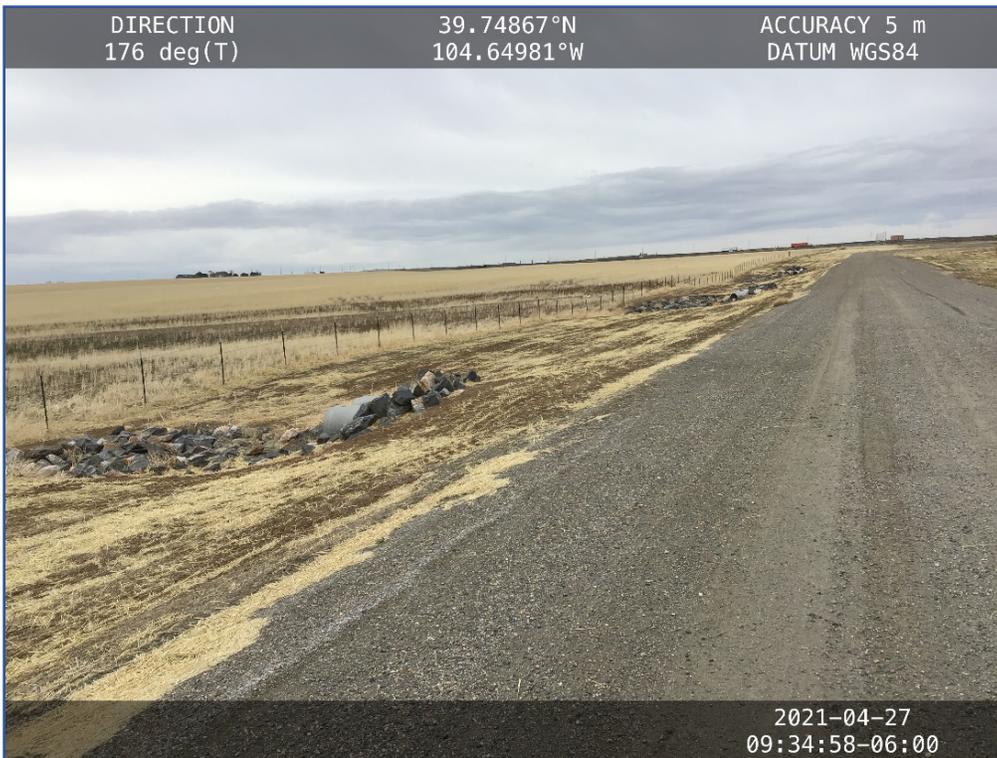
Stormwater control measures are present along the existing oil and gas pad at the southern end of the pipeline and along the access road north and south of Interstate 70 (Attachment B - Photos 10 – 13, and 18). These features are State Waters subject to Colorado Department of Public Health and Environment (CDPHE) stormwater and water quality regulations, but they are not subject to federal Clean Water Act (CWA) Section 404 regulations managed by the U.S. Army Corps of Engineers.

**Photo 10.** Looking south along route where existing stormwater control measures from existing CPR pad and access road intersect with pipeline route.

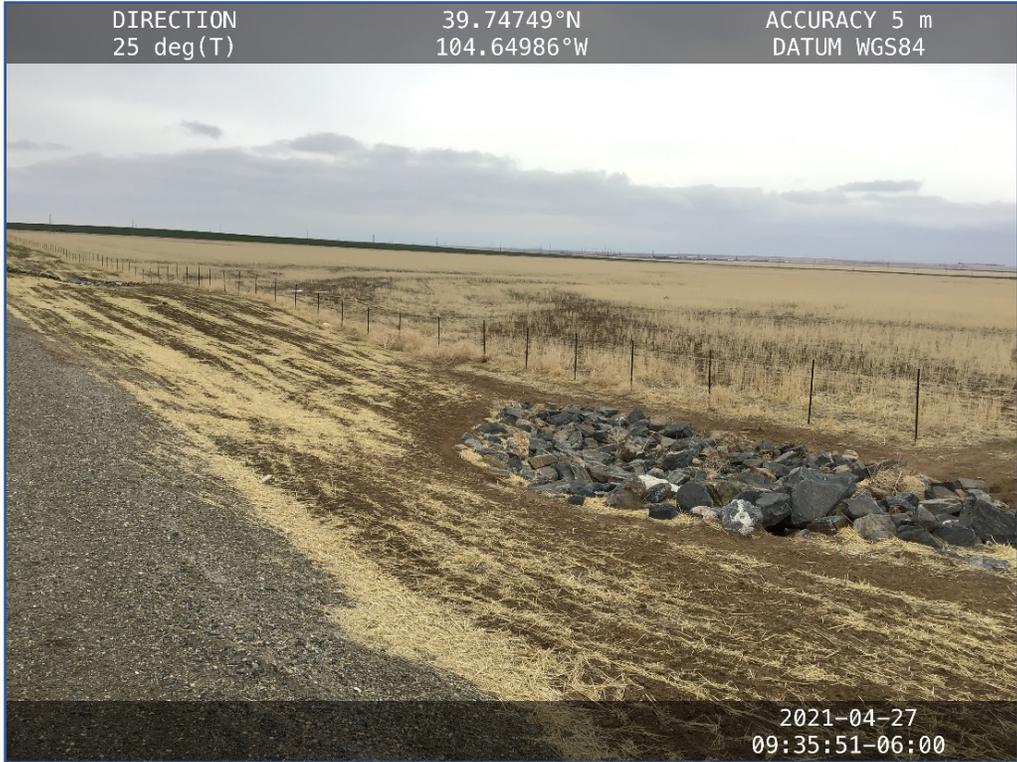
**Photo 11.** Looking northeast along existing stormwater control measures that intersect the route.

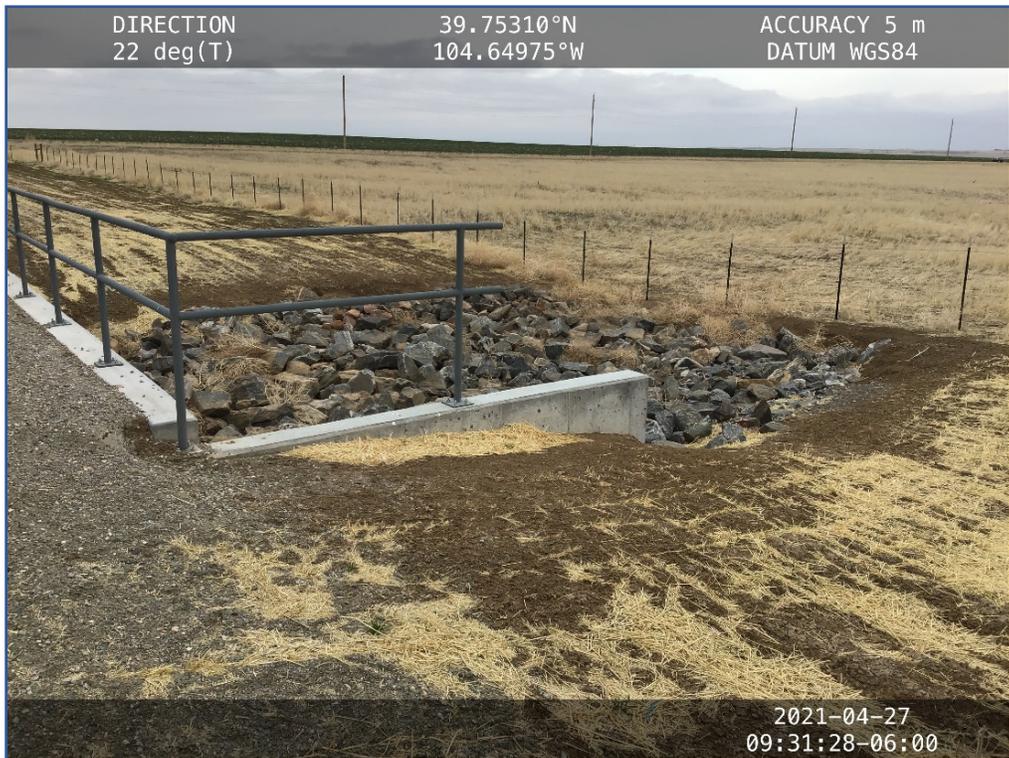
**Photo 12.** Looking northeast along existing stormwater control measures where mapped intermittent stream intersects the northwestern section of the route.

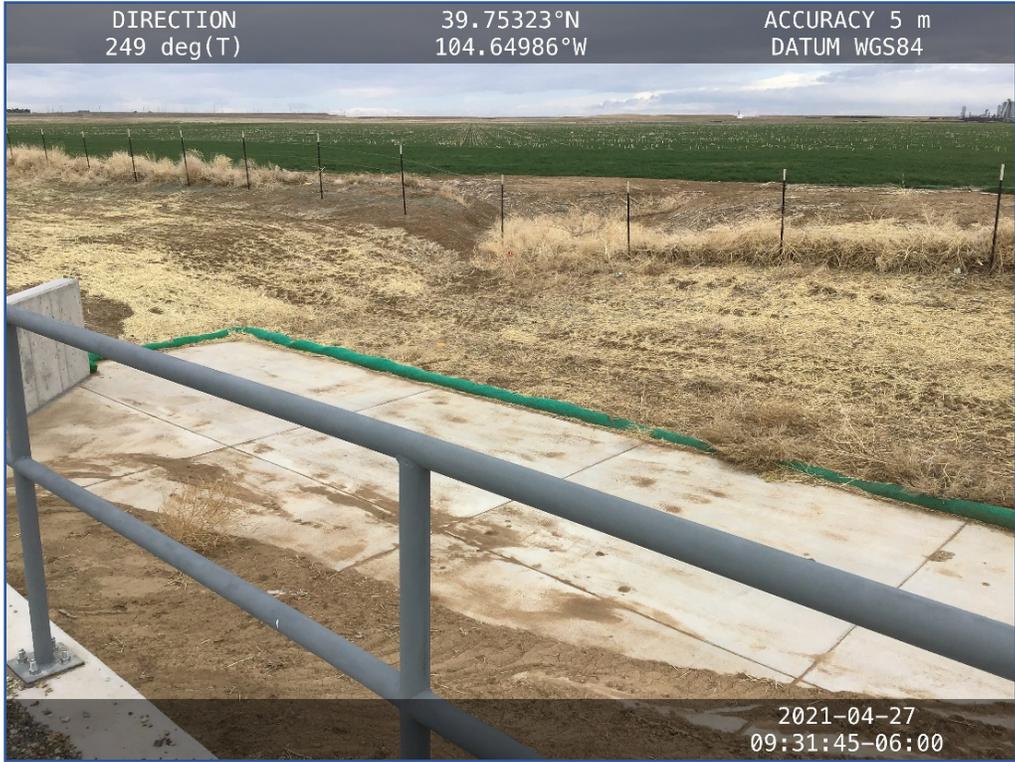
**Photo 13.** Looking southwest along existing stormwater control measures where mapped intermittent stream intersects the northwestern section of the route.

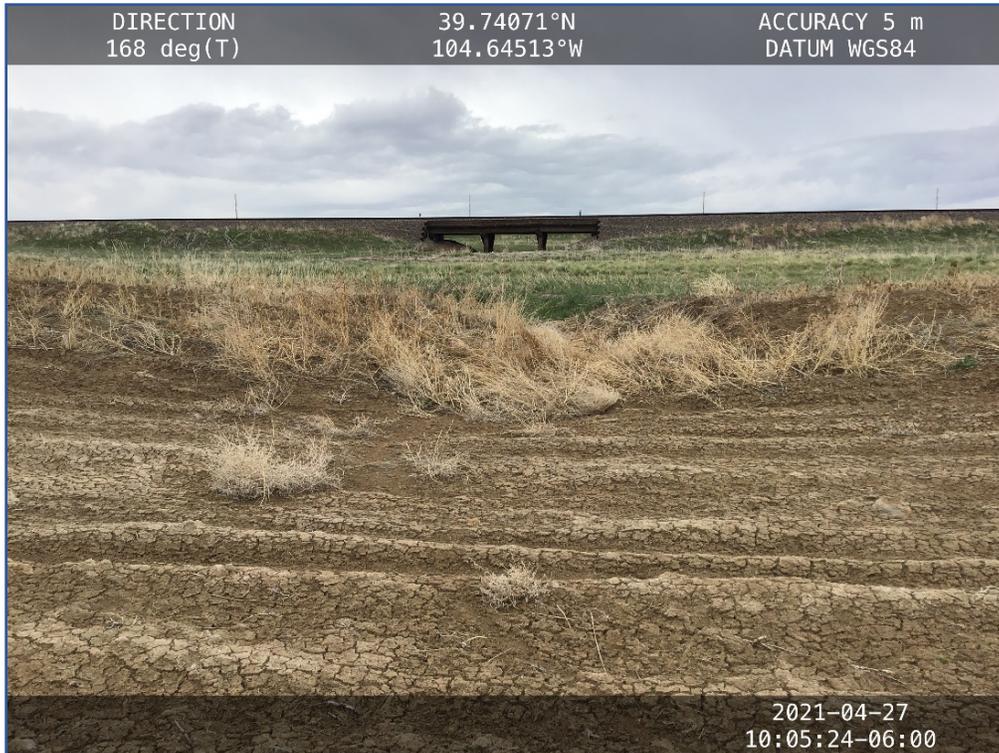
**Photo 15.** Looking south along mapped intermittent stream that intersects southern section of pipeline route north of Interstate 70.

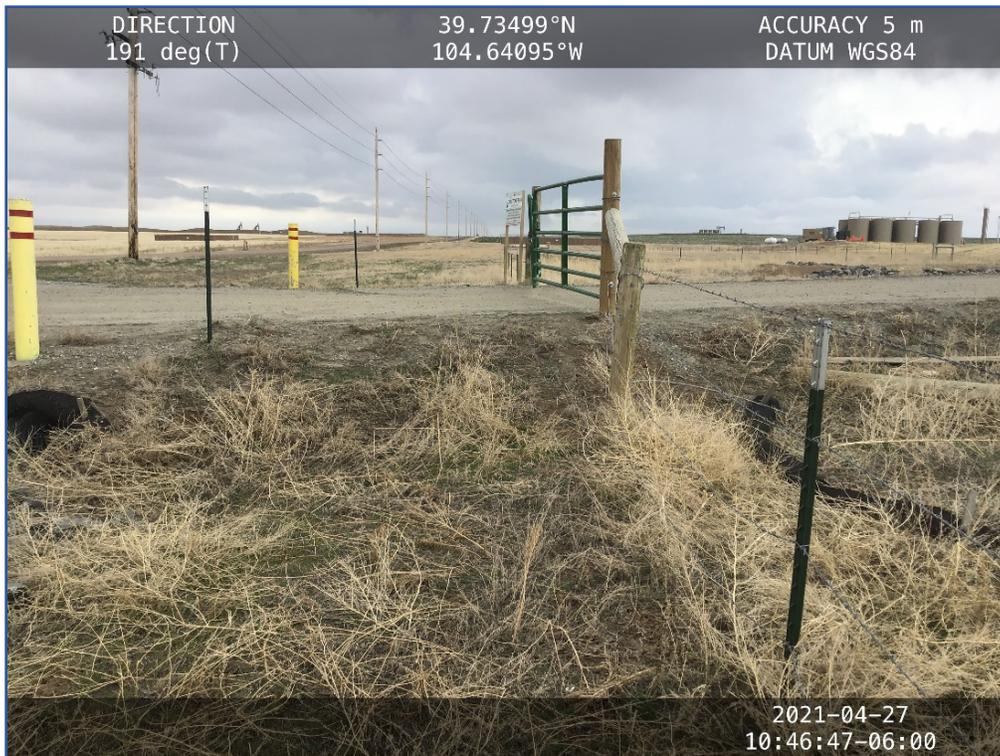
**Photo 18.** Facing south towards southern terminus intersecting with existing CPR pad access road and stormwater control measures.
